Thermal inspection

Site location	123456 Bussell Highway, Busselton 6280
Job Number	7890
Customers name	Big Tank Wines
Date/Time	01/01/2025

DB Location	Boundary
DB Name	Site main switch
Number of RCD per board	None
SWB neatly Labelled or is there a DB Legend?	Sub mains labeled ok. Unknown circuit on top rail, no labelling
Is the Insulated Busbar in good condition?	Yes
Are there any Missing Pole Fillers?	No
Missing Screws?	No
Wiring Condition?	Good
Are there any Holes / Penetrations on the board?	No
Are electrical circuits RCD protected?	NA
Are there Recalled RCD's Installed?	NA
Thermal Status	Hot spot on blue phase on unknown circuit

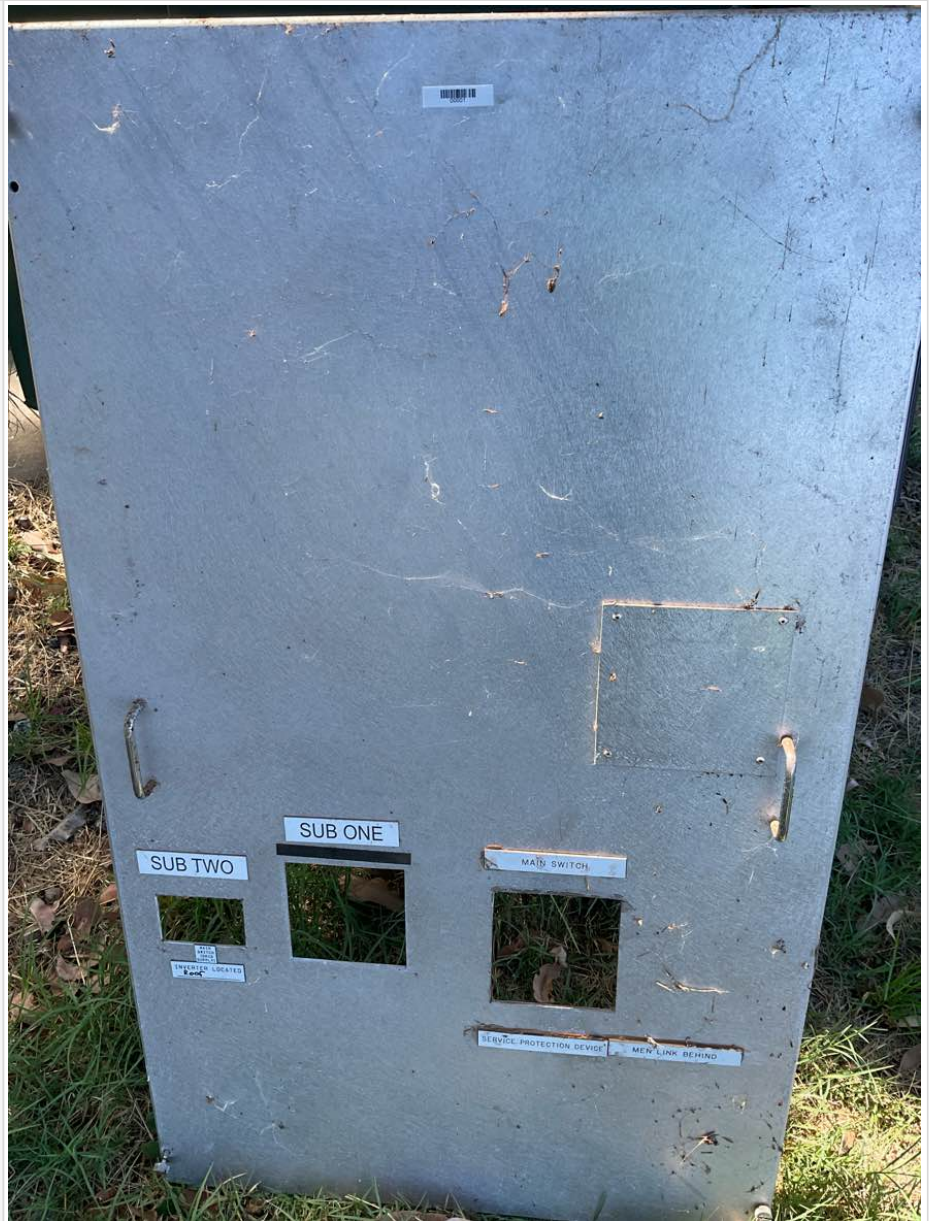
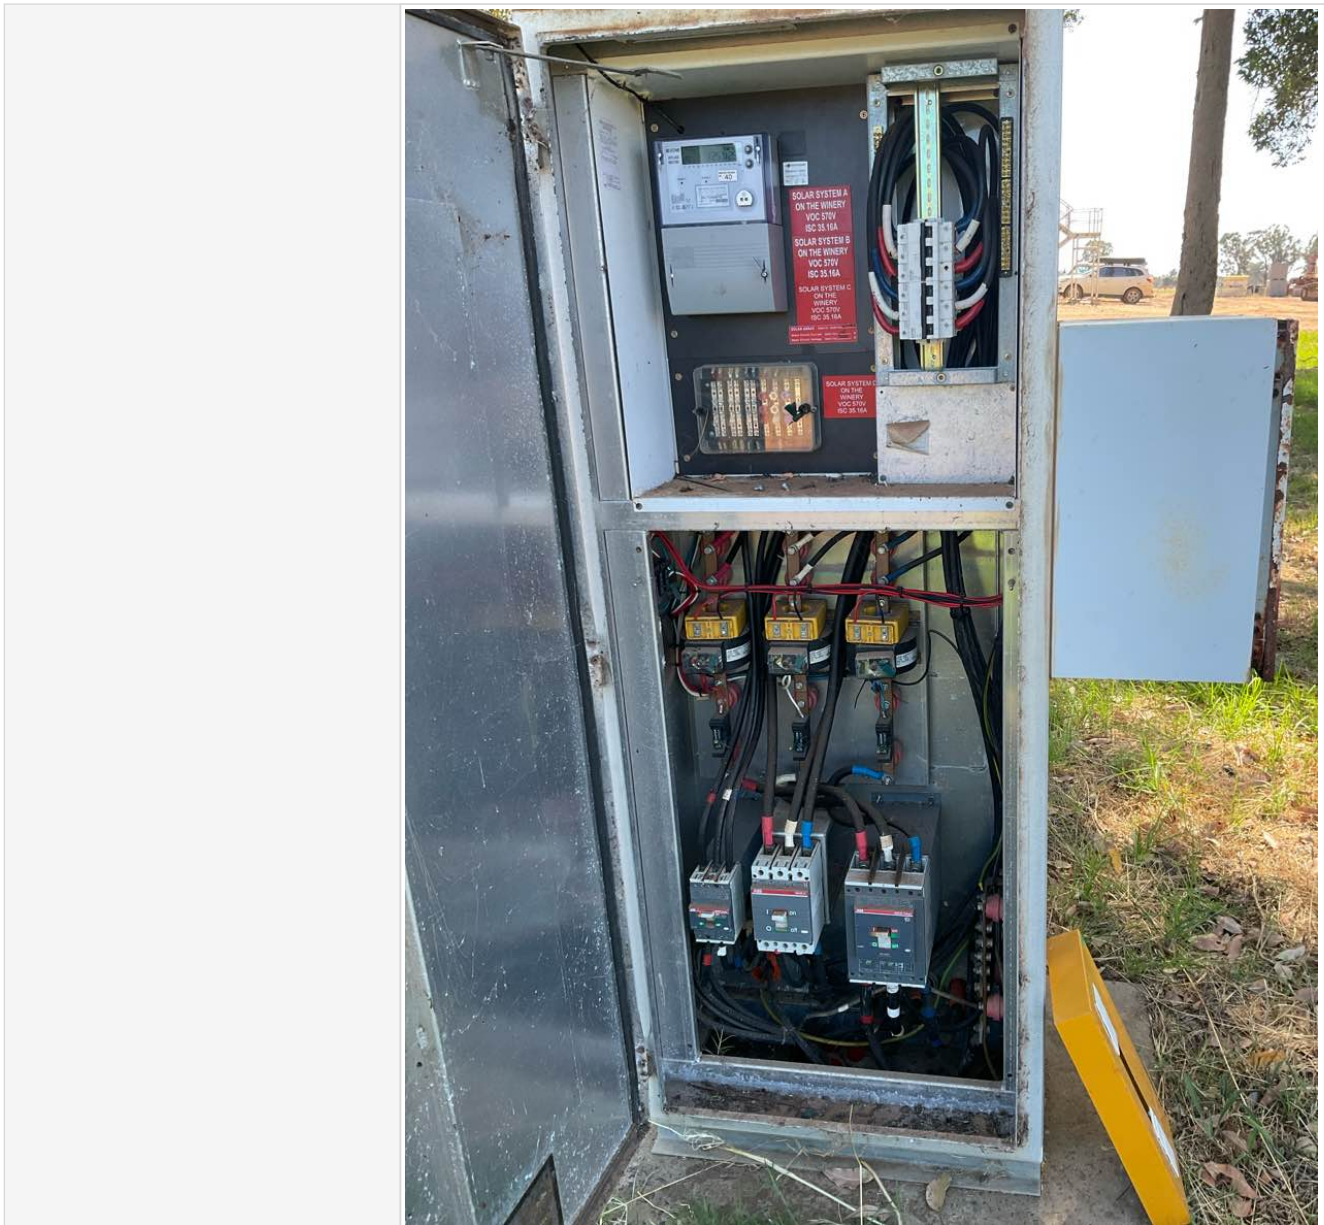
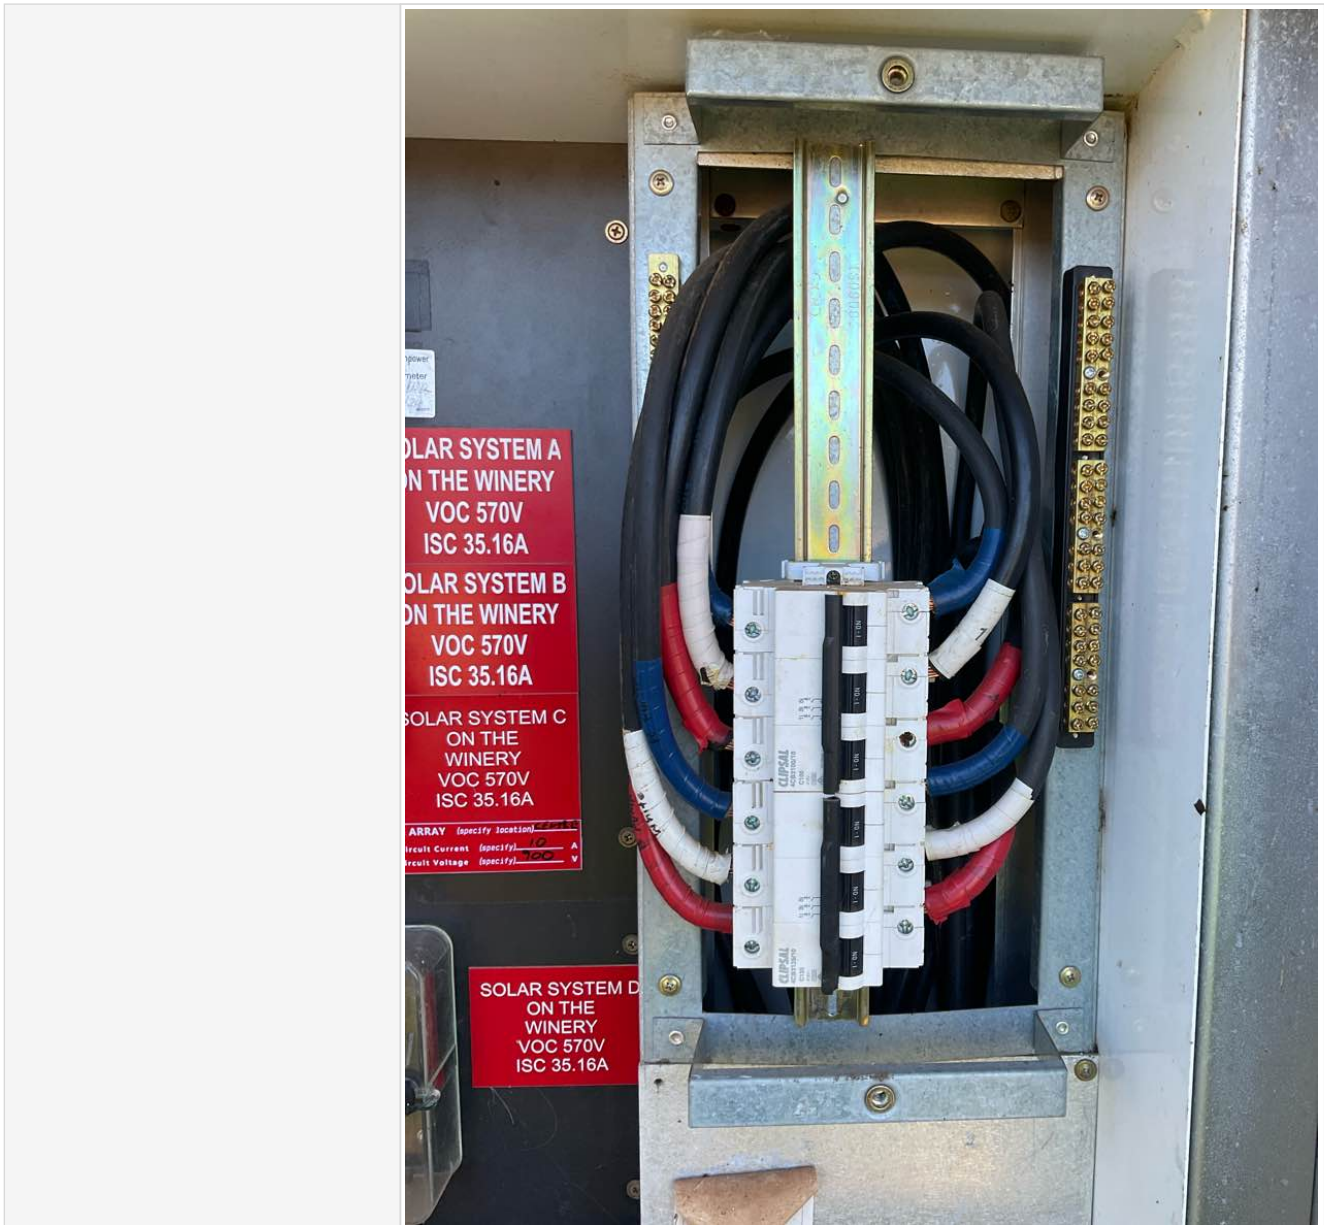
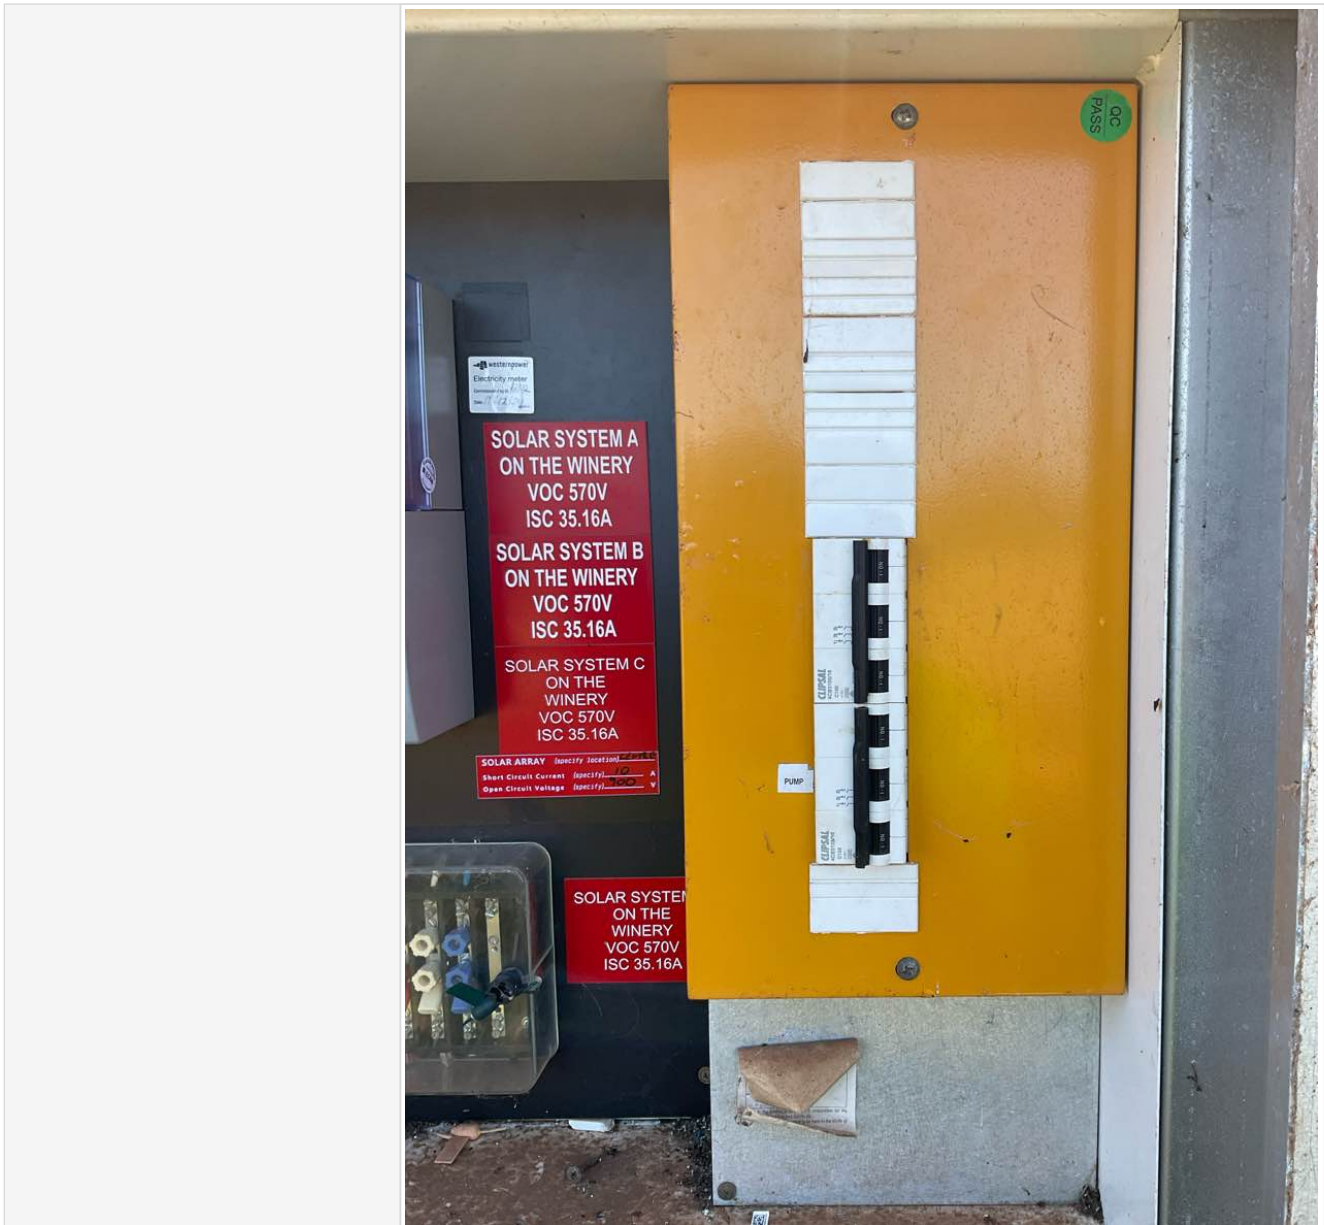
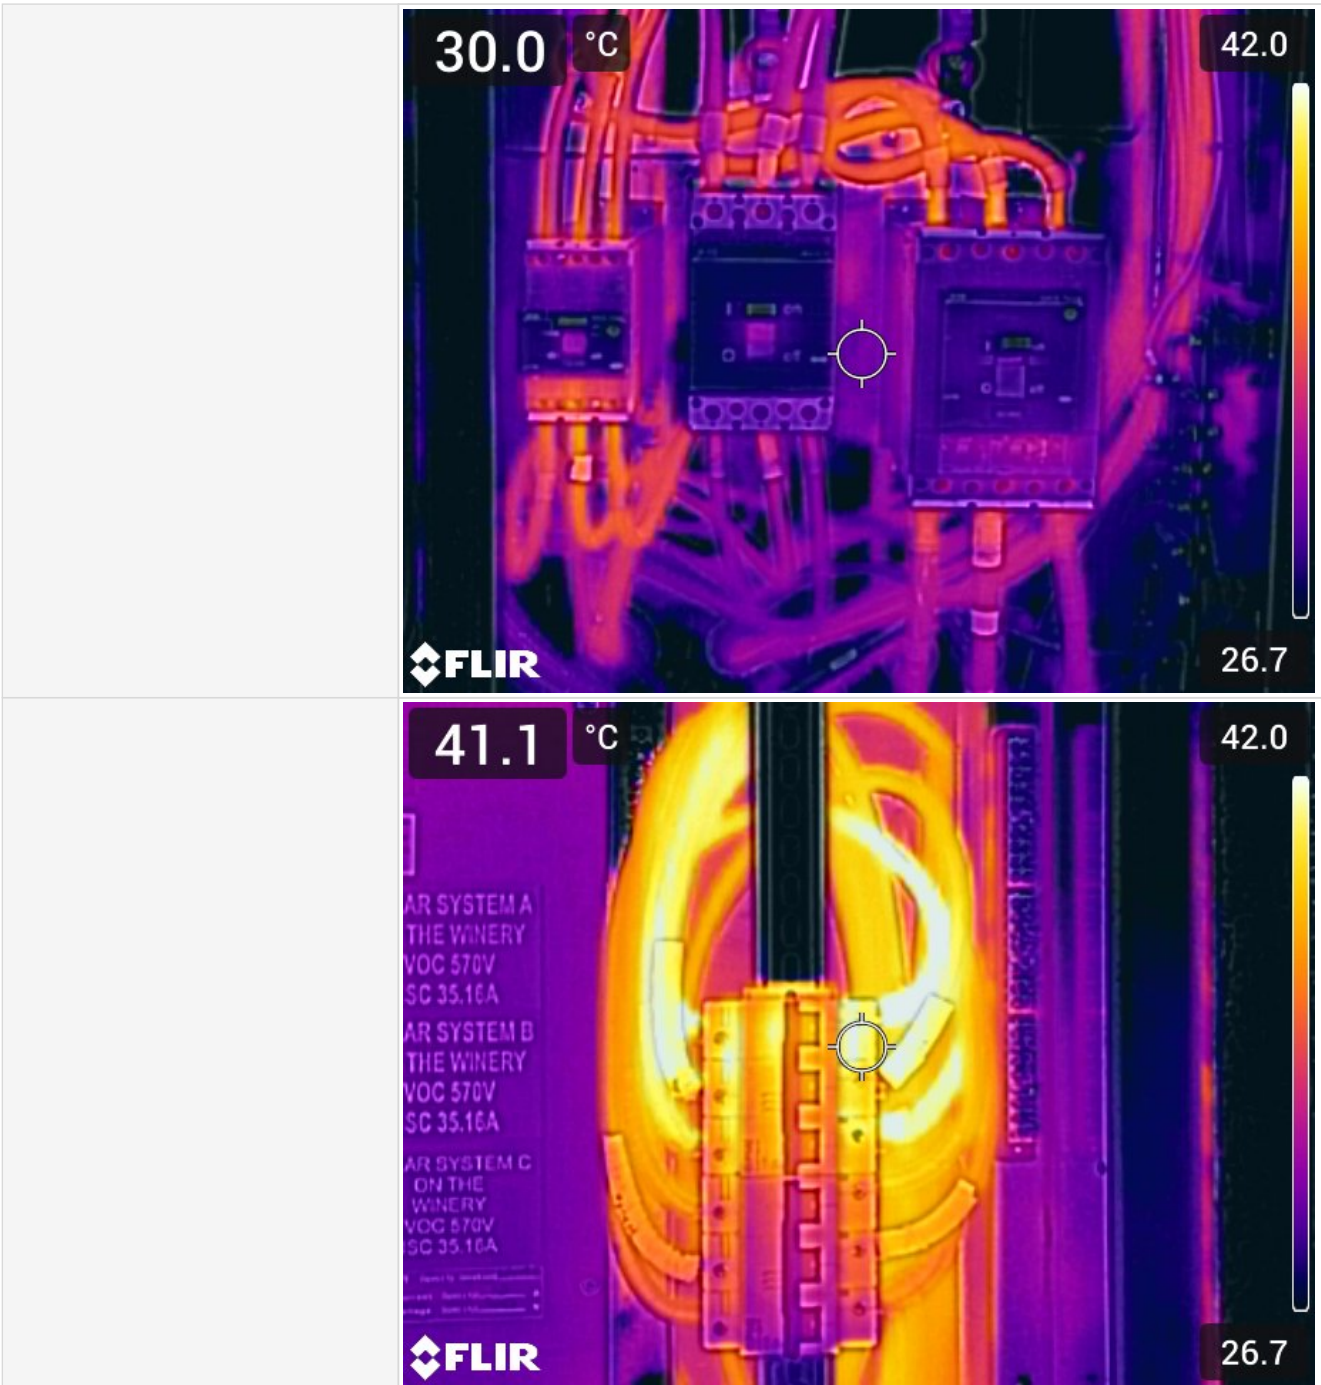
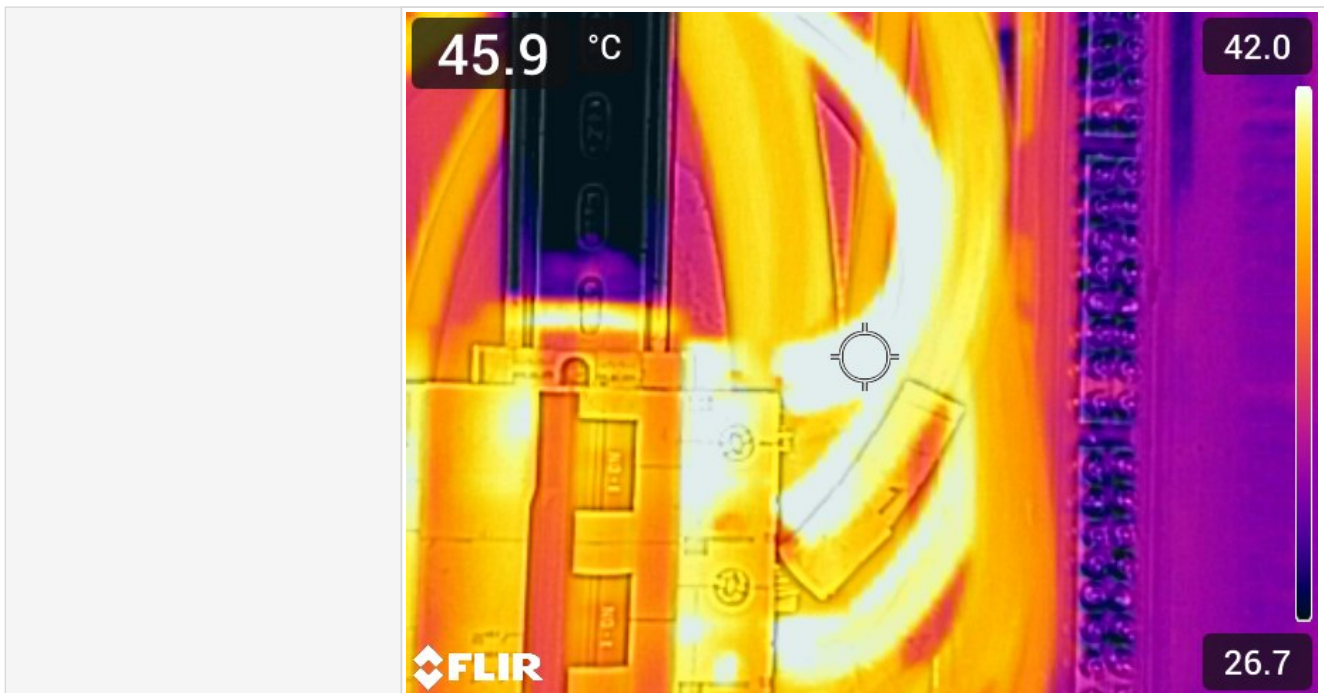
Switchboard Inspection Status	Pass
Comments and Recommendations	100A circuit break on top isn't labelled Hot spot on blue phase <45 Degrees Cables reterminated and labelled
Next inspection Due	Feb 2026

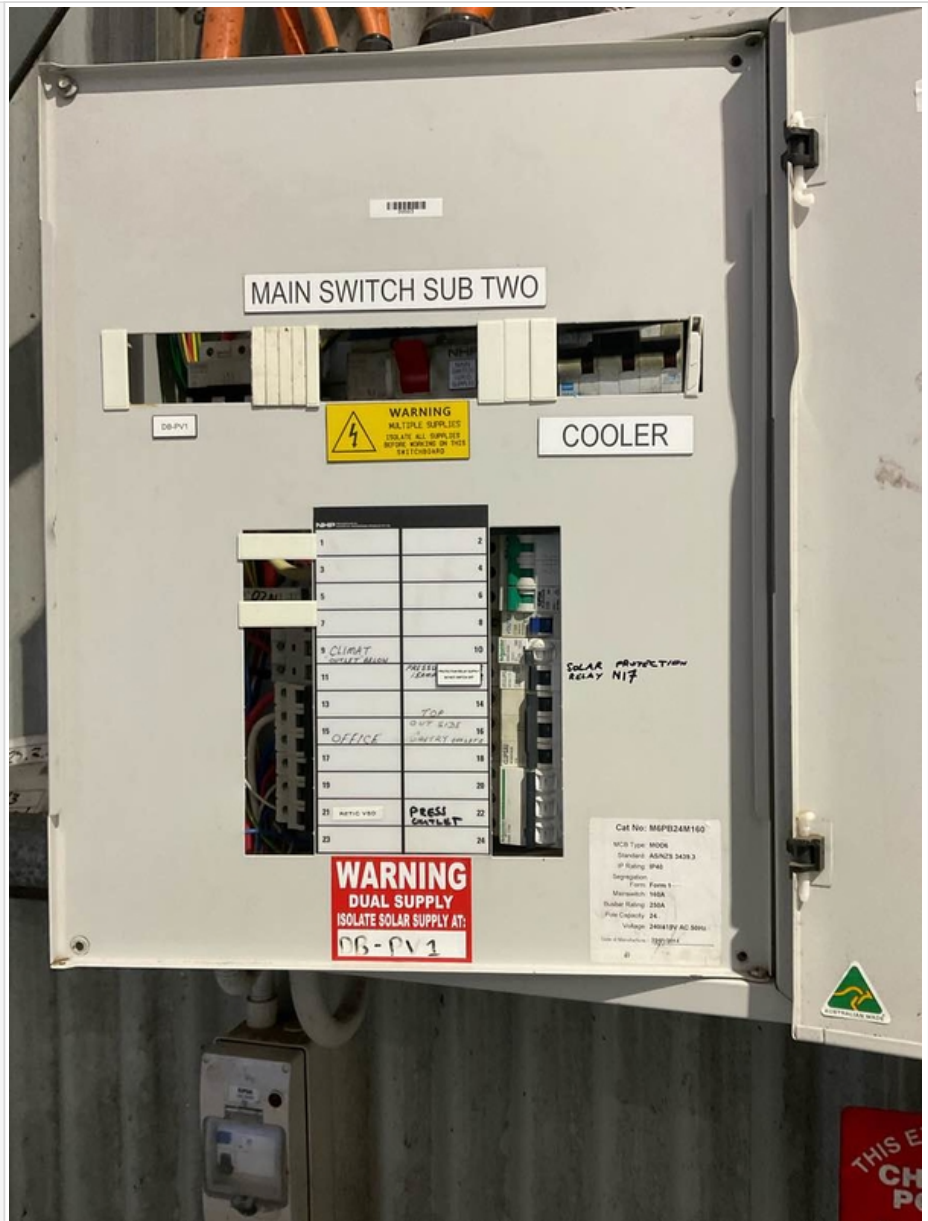
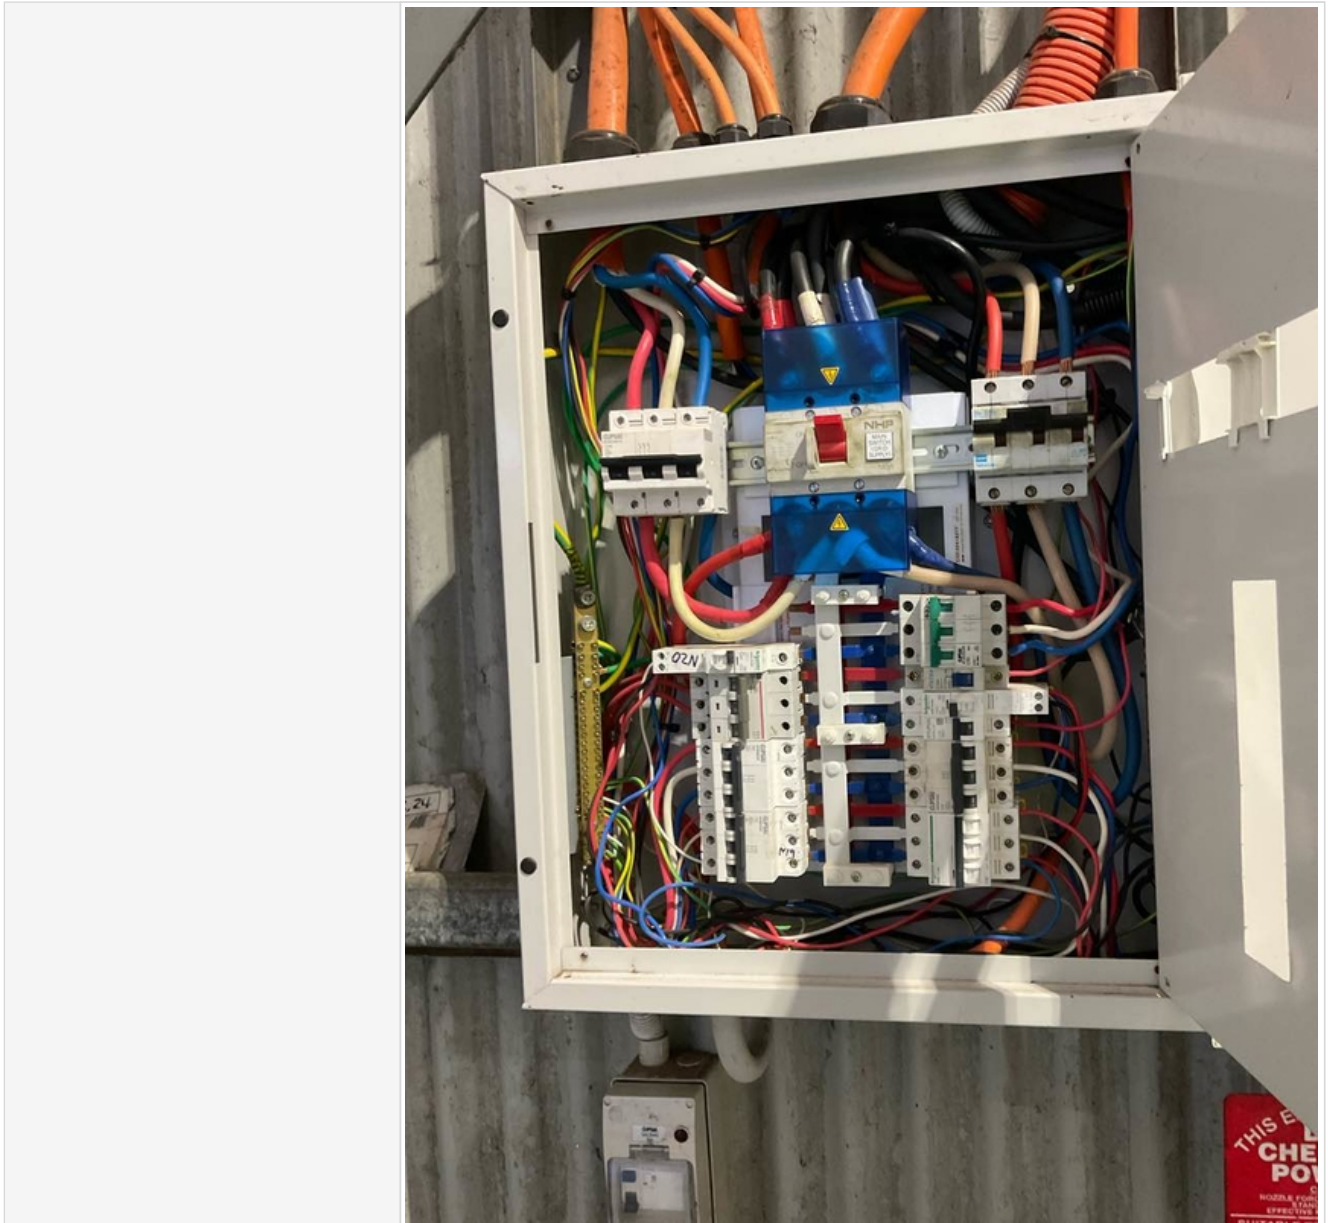
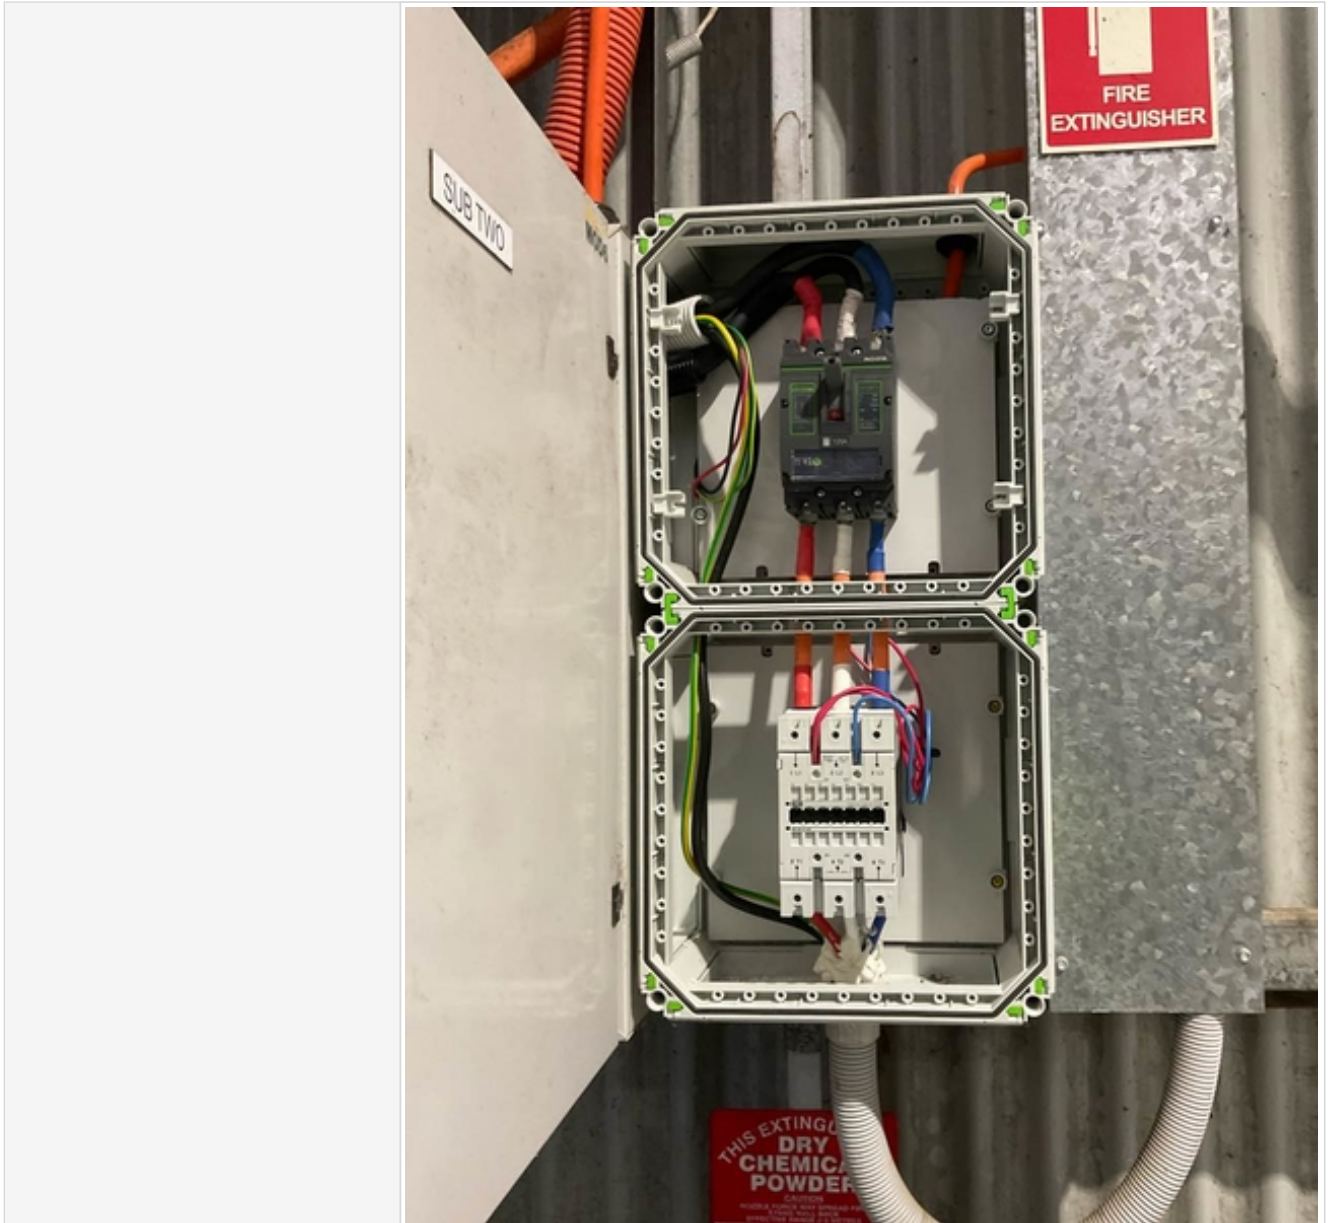
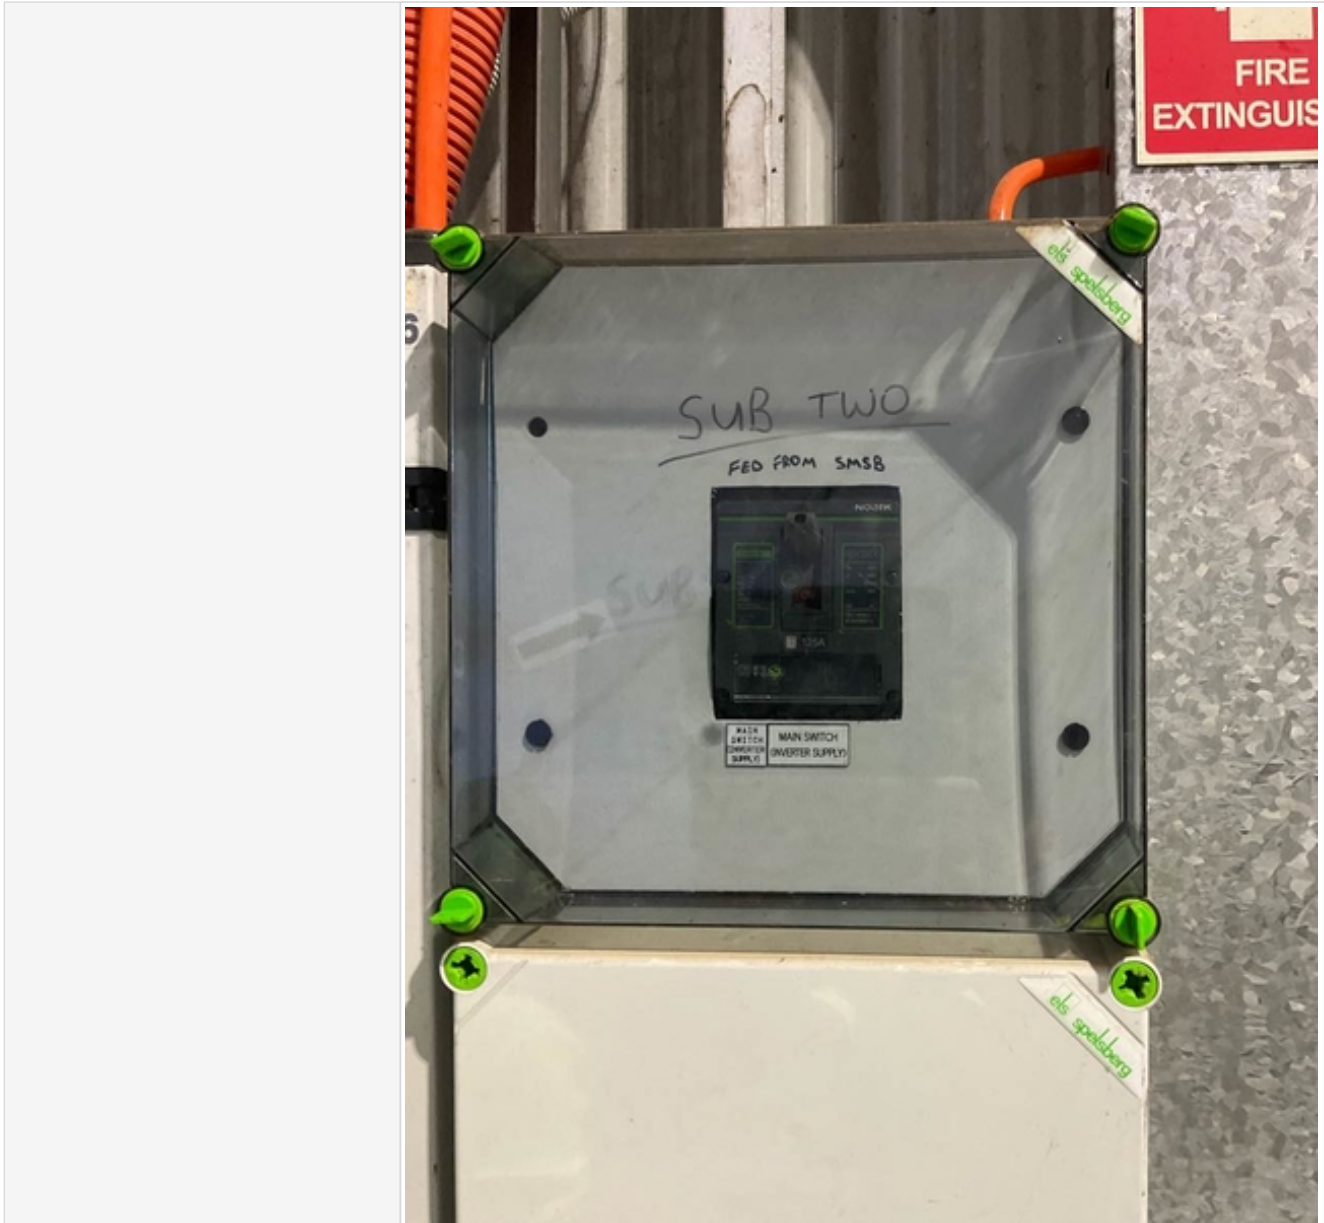
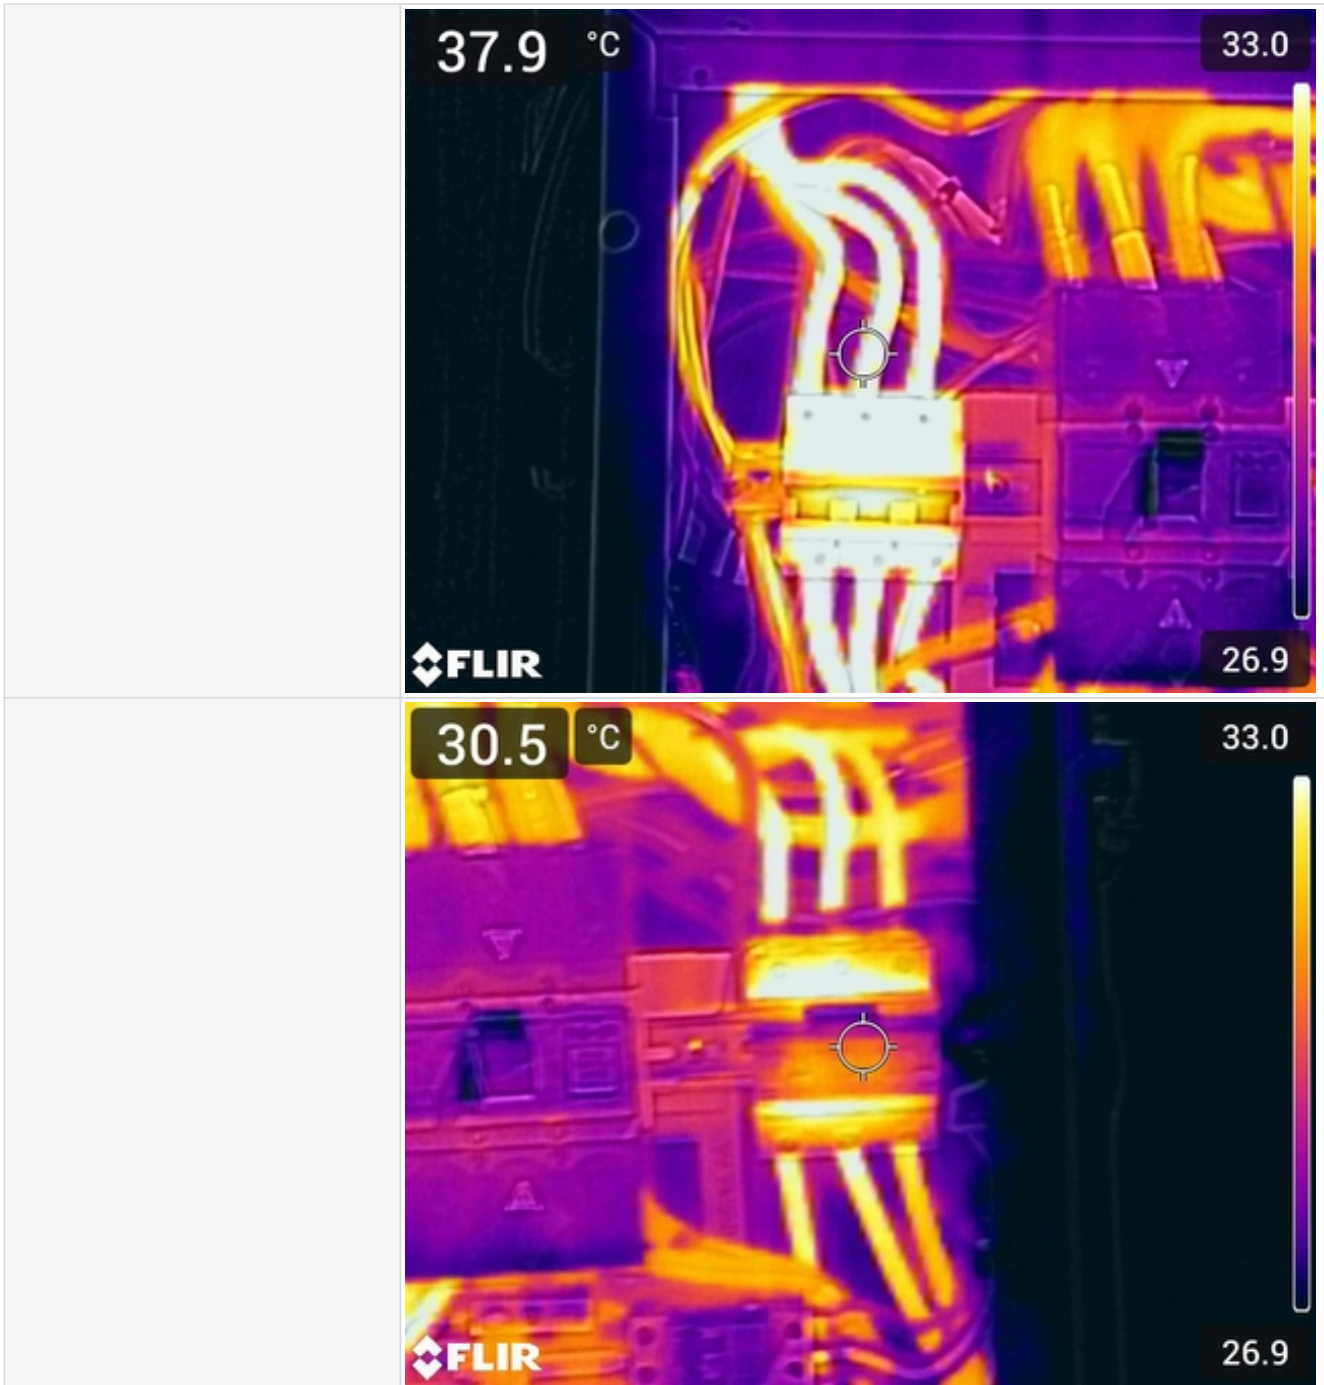
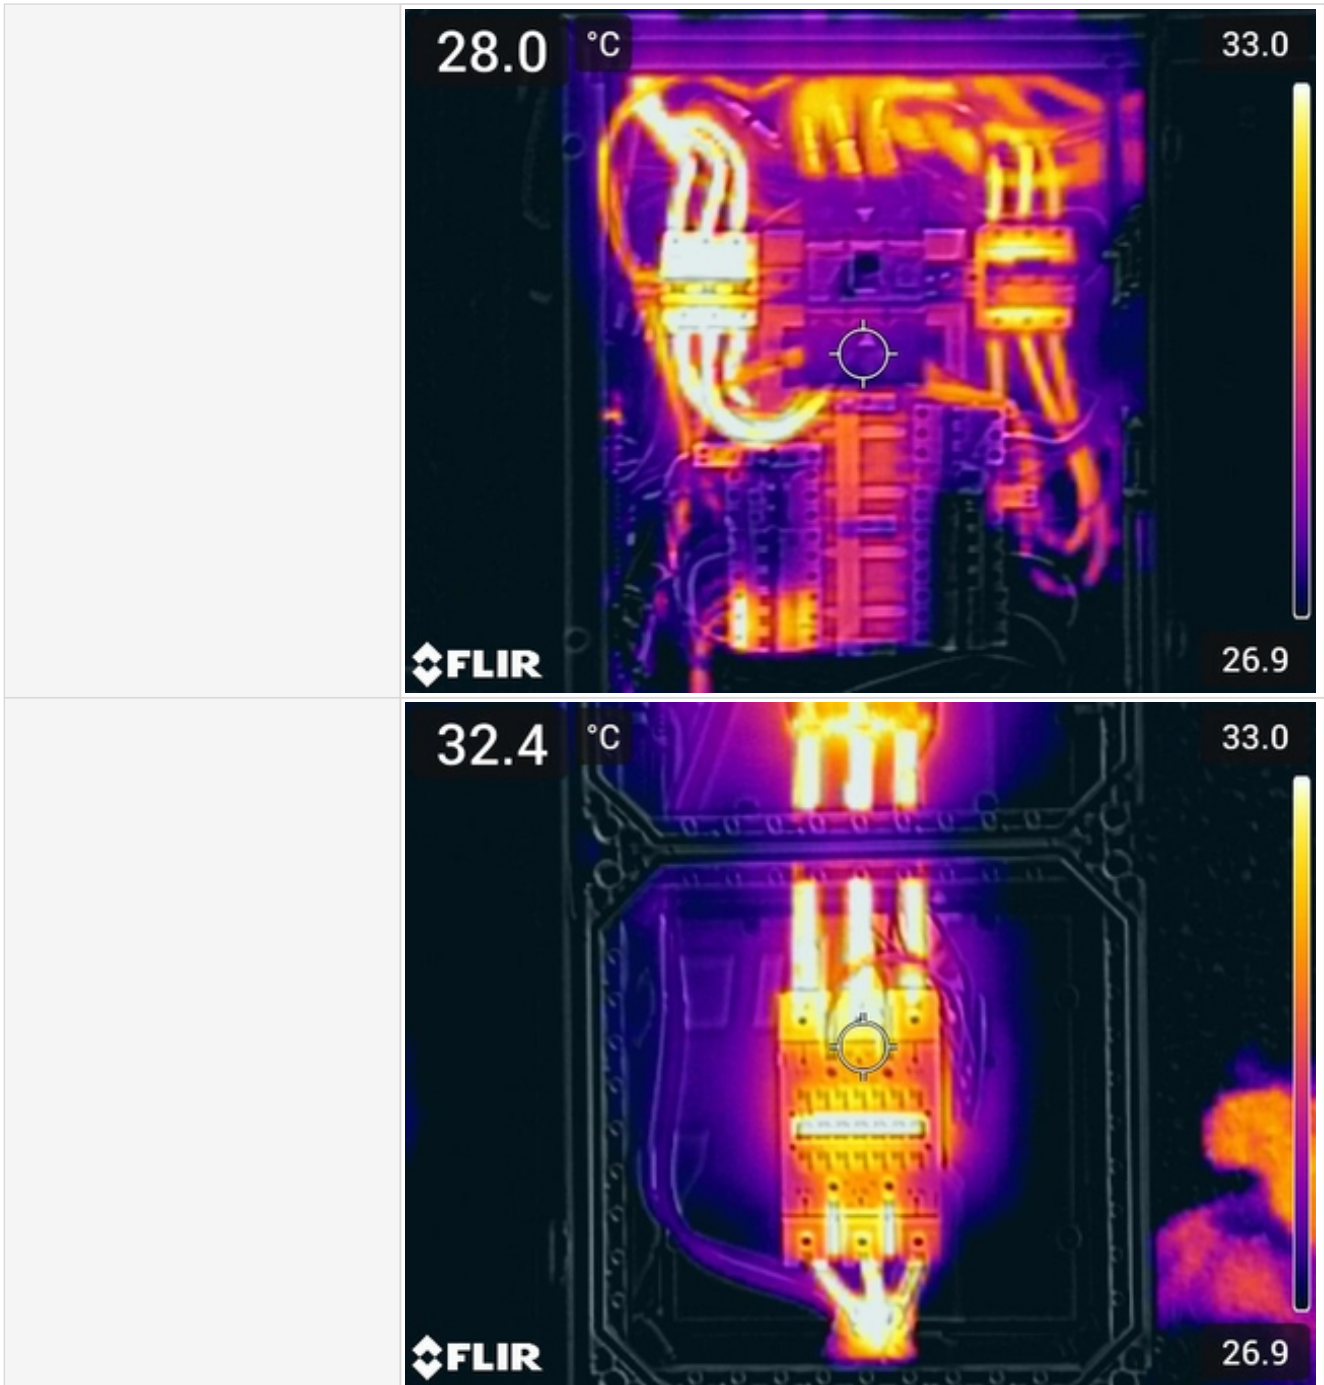
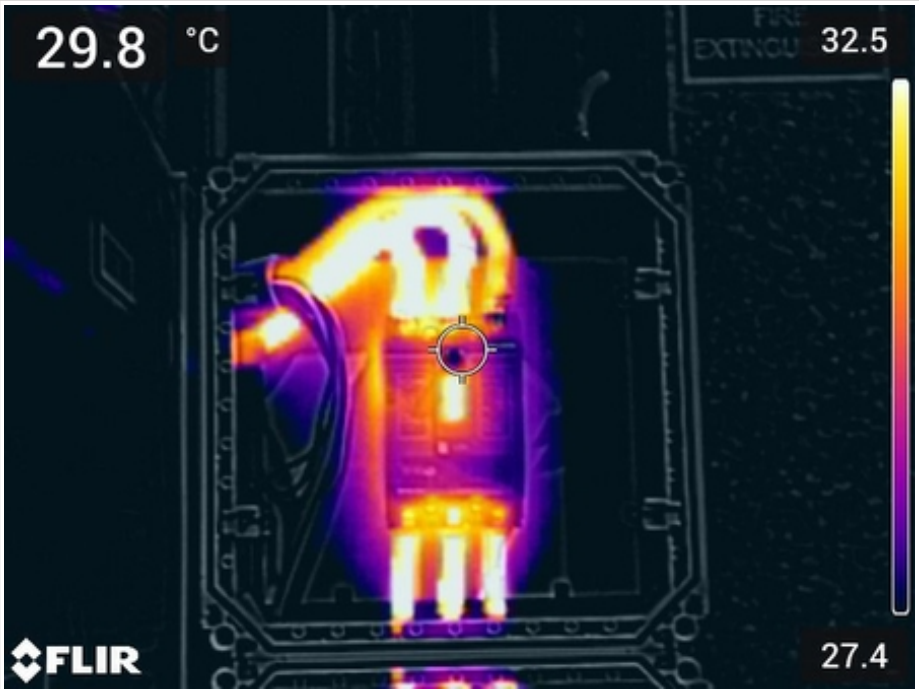
Number of RCD per board	2
SWB neatly Labelled or is there a DB Legend?	Yes
Is the Insulated Busbar in good condition?	Yes
Are there any Missing Pole Fillers?	No
Missing Screws?	No
Wiring Condition?	Fair, exposed copper on cooler circuit breaker
Are there any Holes / Penetrations on the board?	No
Are electrical circuits RCD protected?	Yes
Are there Recalled RCD's Installed?	No
Thermal Status	Pass

Switchboard Inspection Status	Pass
Comments and Recommendations	Exposed copper termination in cooler circuit breaker. Suggest retermination Appears to be unbalanced load on red and white phase
Next inspection Due	Feb 2026

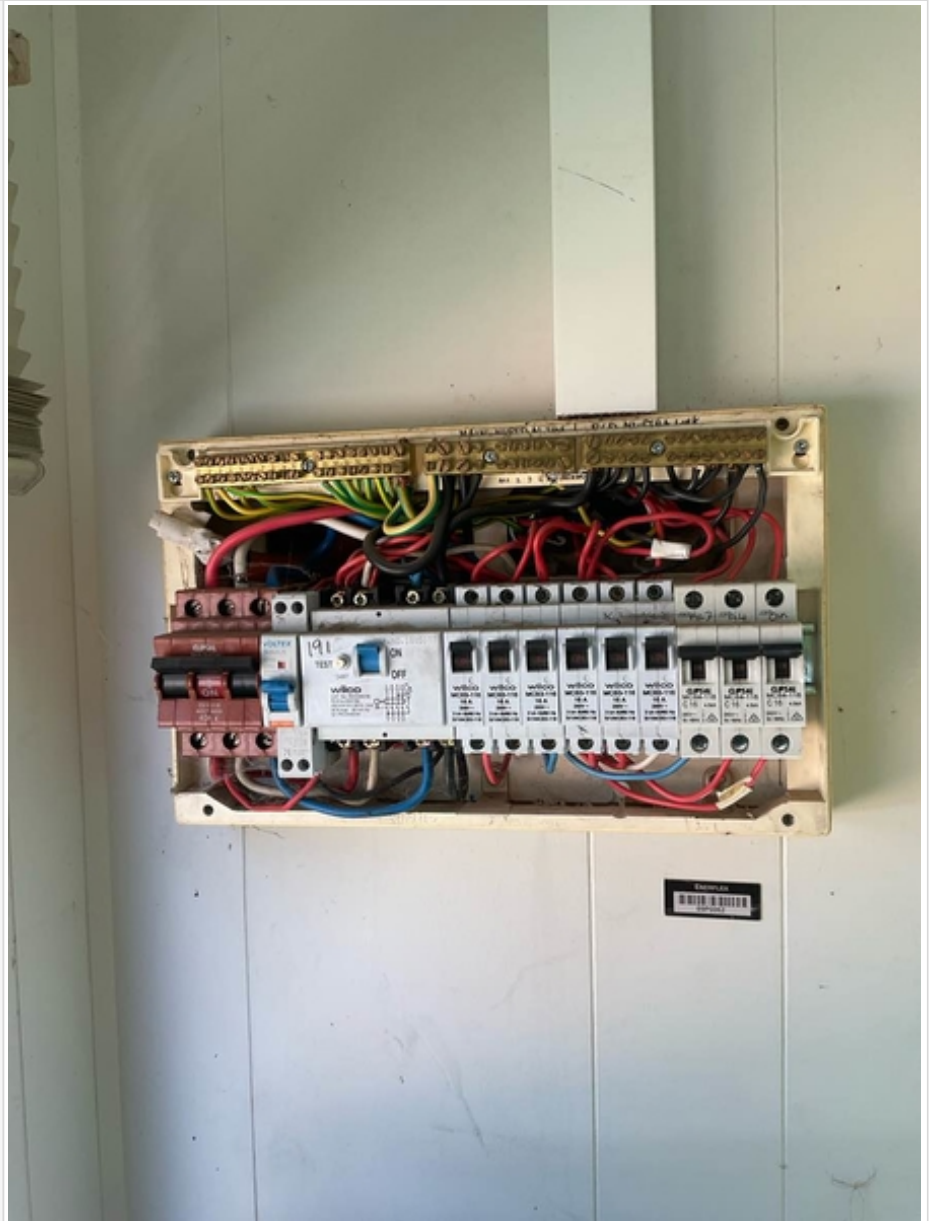
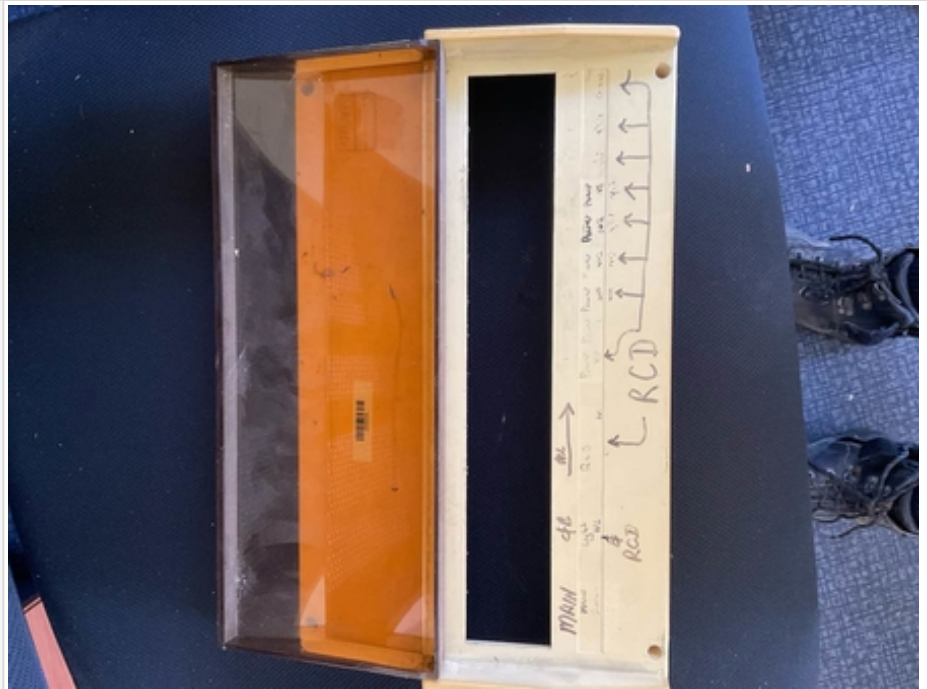
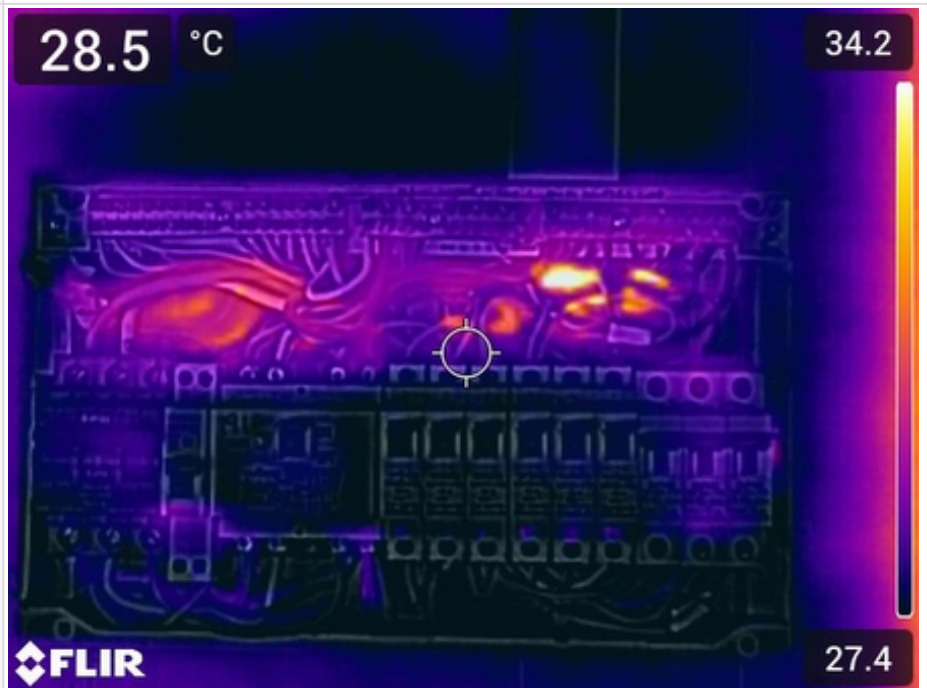
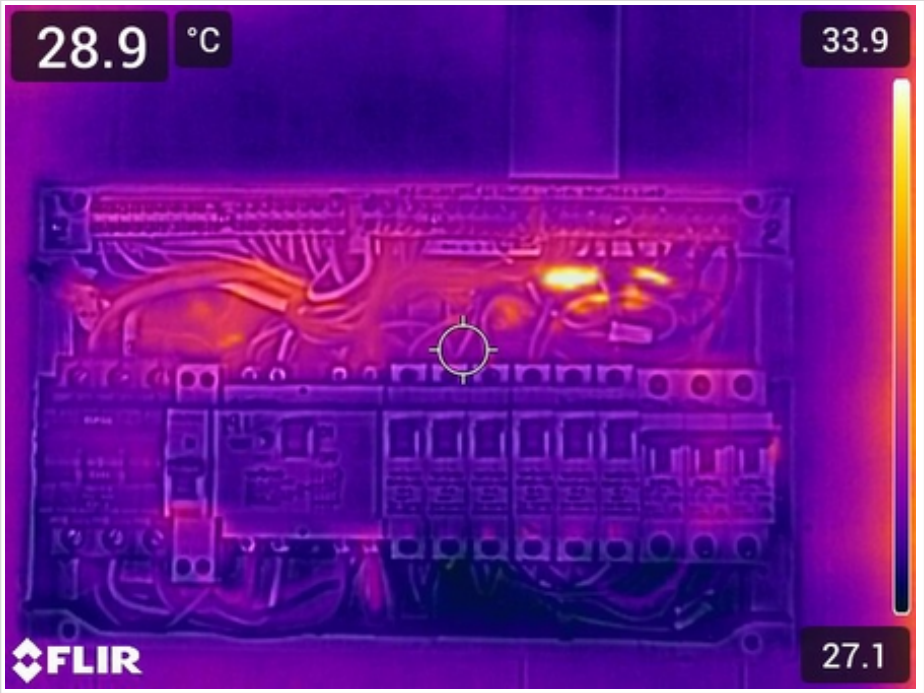
DB Location	Office
DB Name	Office db
Number of RCD per board	2
SWB neatly Labelled or is there a DB Legend?	No
Is the Insulated Busbar in good condition?	NA
Are there any Missing Pole Fillers?	No
Missing Screws?	No
Wiring Condition?	Fair
Are there any Holes / Penetrations on the board?	No
Are electrical circuits RCD protected?	Yes
Are there Recalled RCD's Installed?	Yes
Thermal Status	Pass

Switchboard Inspection Status	Pass
Comments and Recommendations	SWB labels remarked
Next inspection Due	Feb 2026
