Thermal inspection

Site location	123456 Bussell Highway, Busselton 6280
Job Number	7890
Customers name	Big Tank Wines
Date/Time	01/01/2025

DB Location	Boundary
DB Name	Site main switch
Number of RCD per board	None
SWB neatly Labelled or is there a DB Legend?	Sub mains labeled ok. Unknown circuit on top rail, no labelling
Is the Insulated Busbar in good condition?	Yes
Are there any Missing Pole Fillers?	No
Missing Screws?	No
Wiring Condition?	Good
Are there any Holes / Penetrations on the board?	No
Are electrical circuits RCD protected?	NA
Are there Recalled RCD's Installed?	NA
Thermal Status	Hot spot on blue phase on unknown circuit

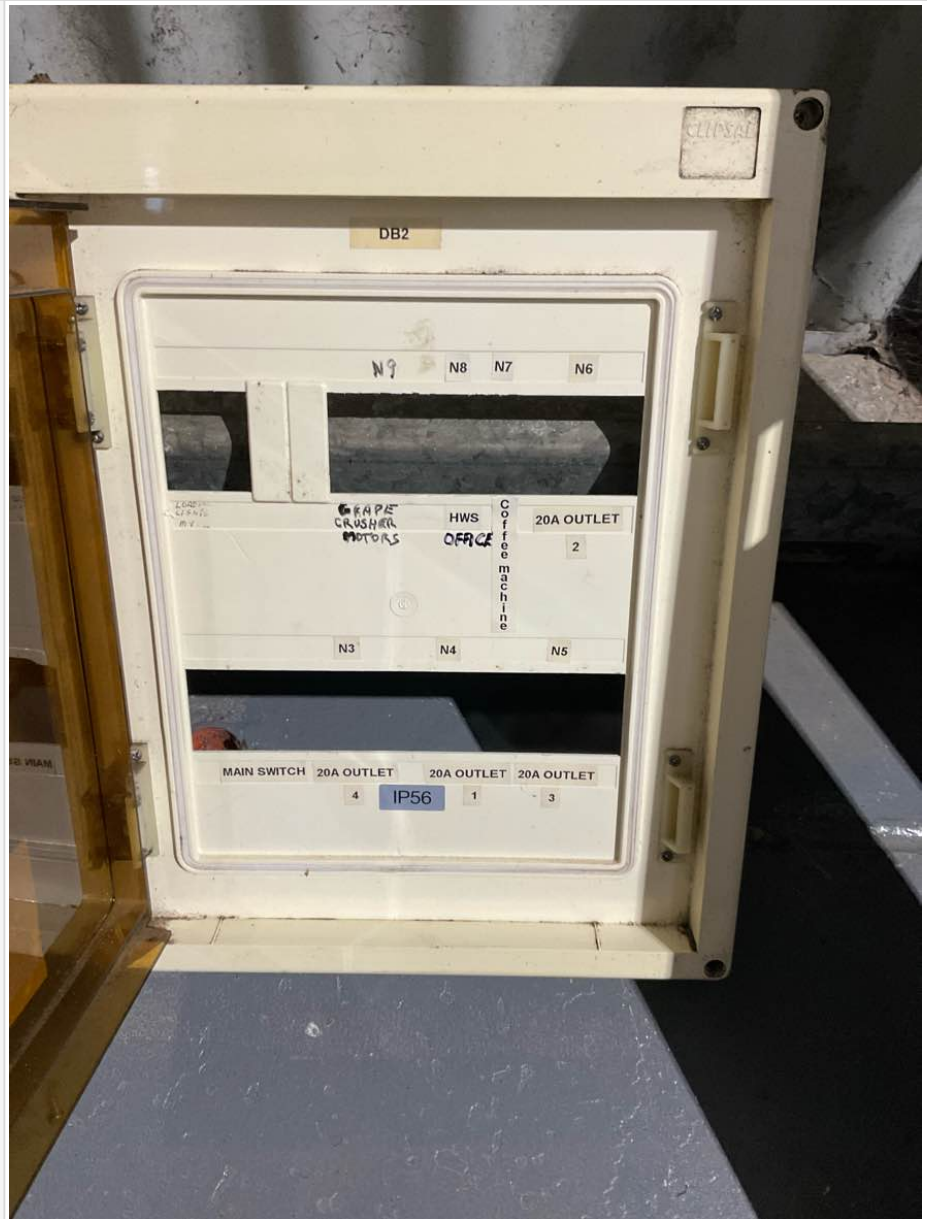
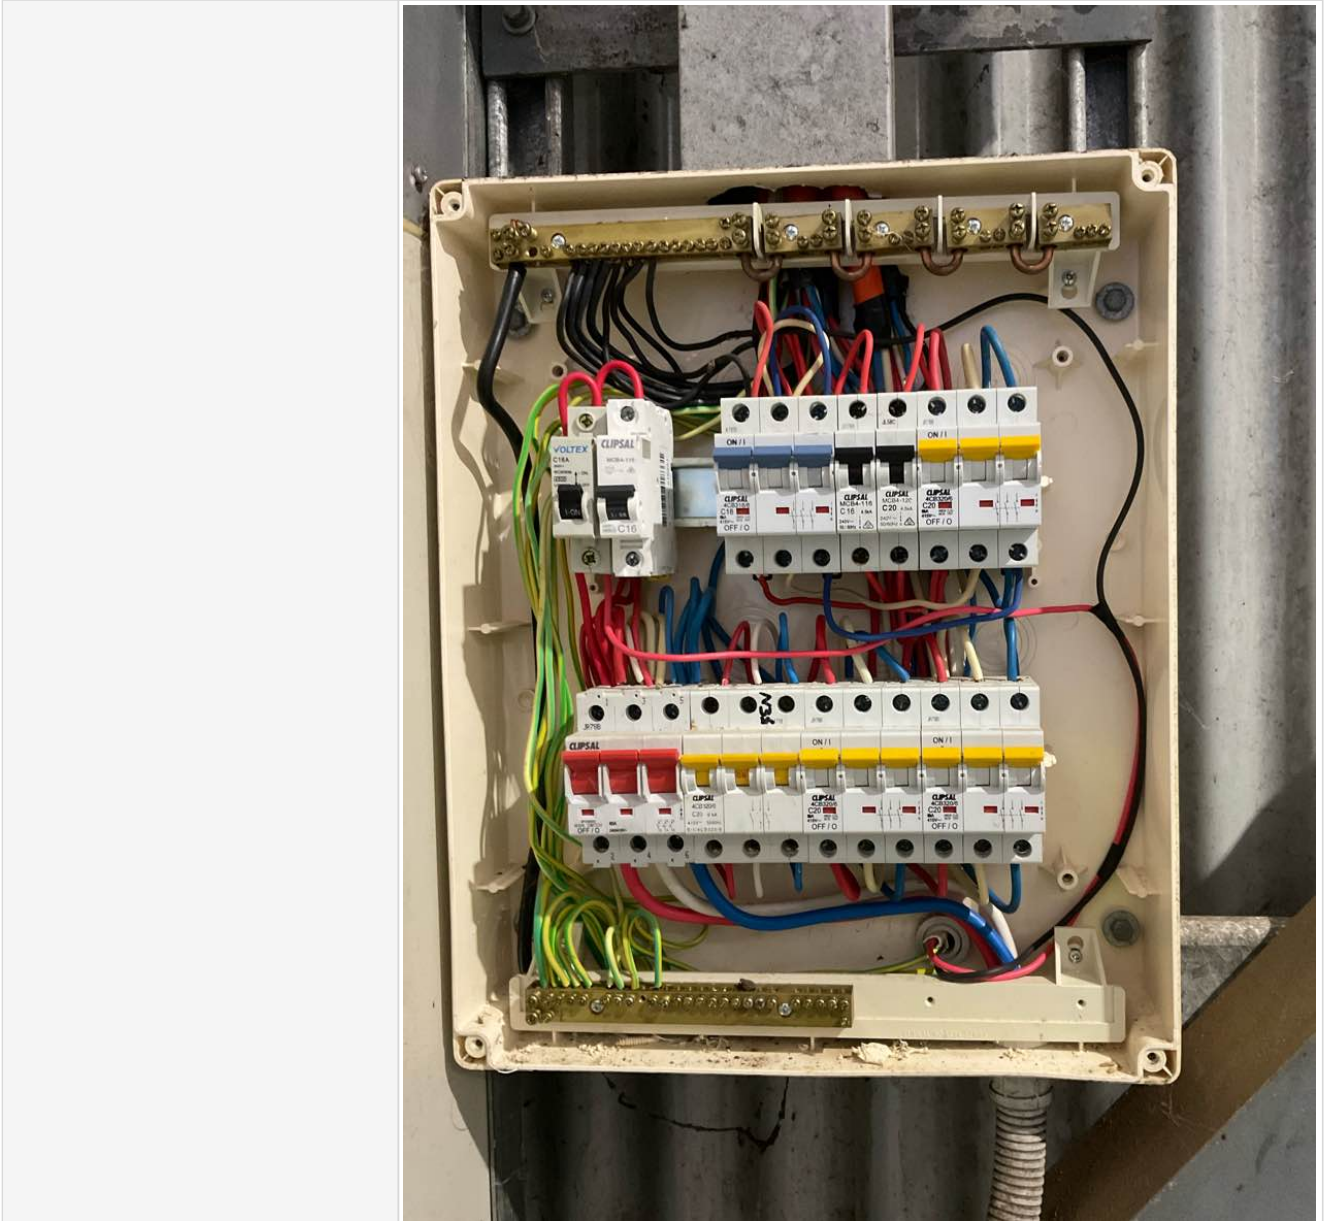
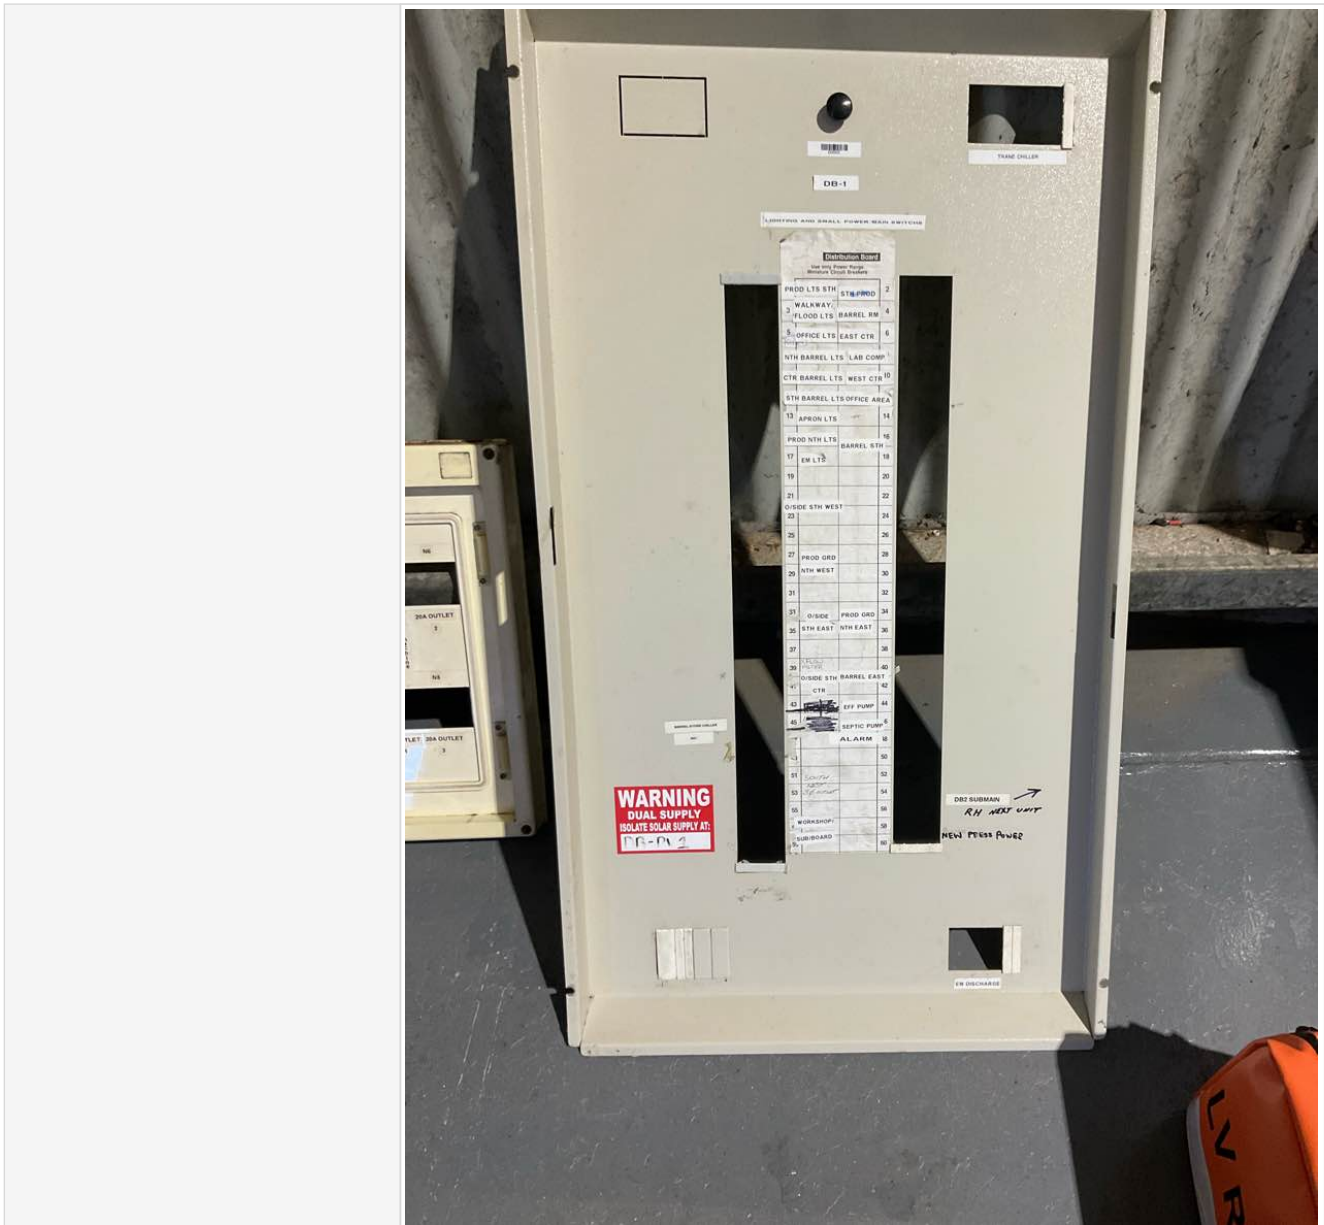
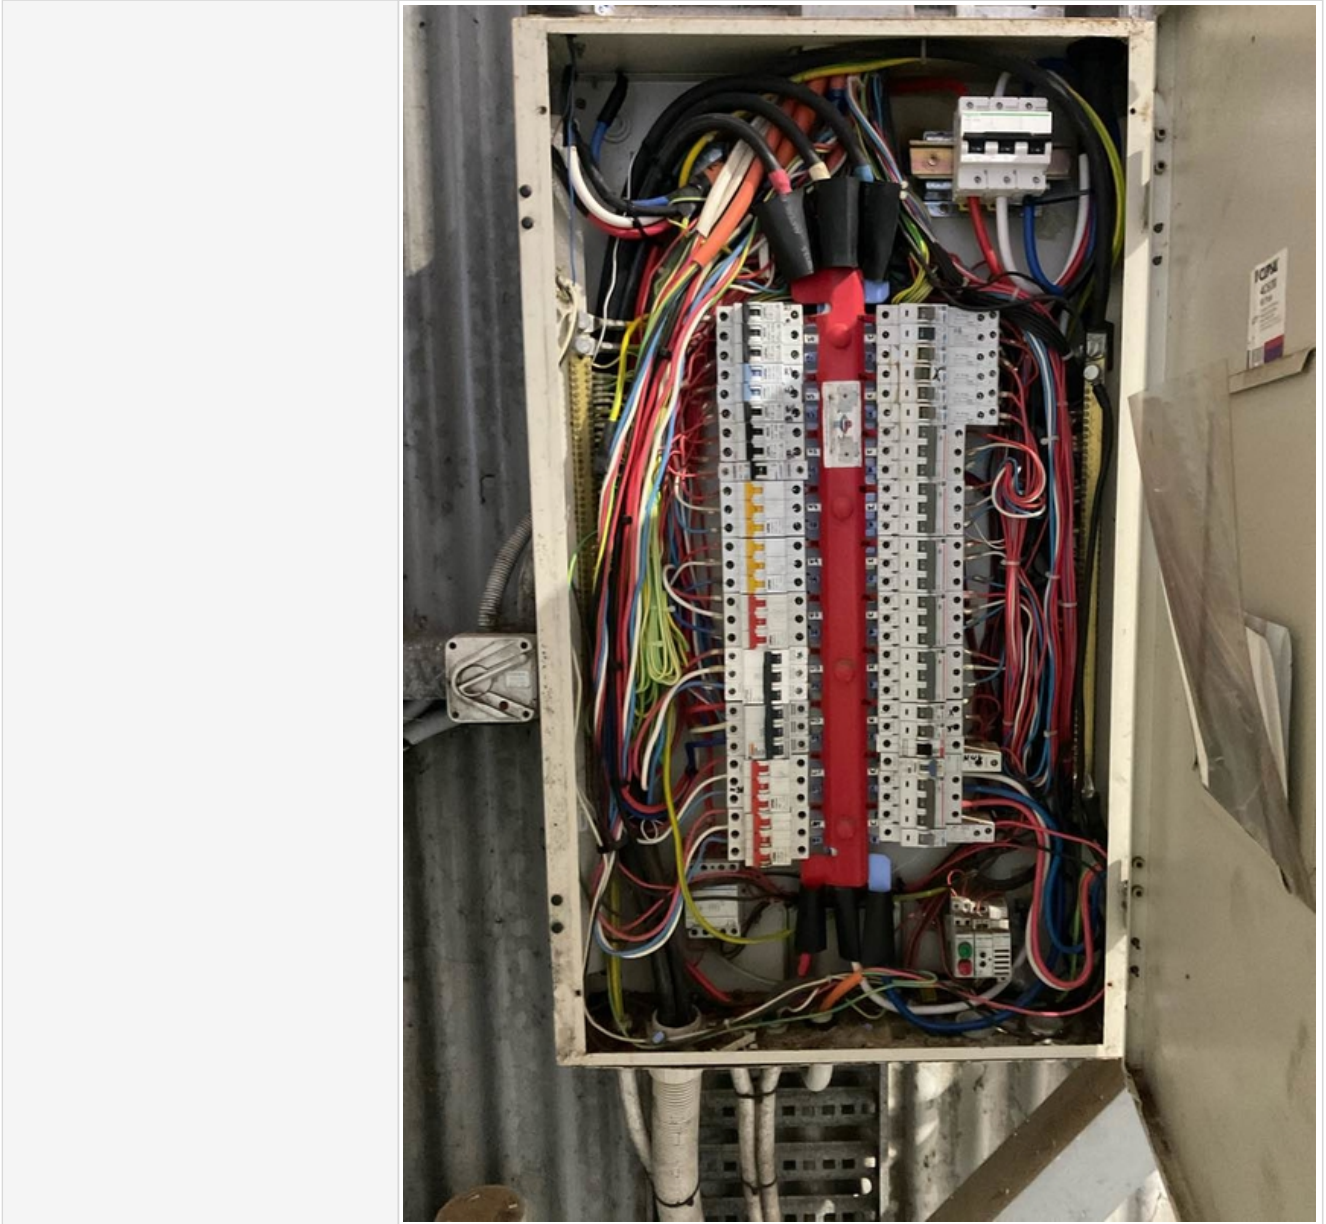
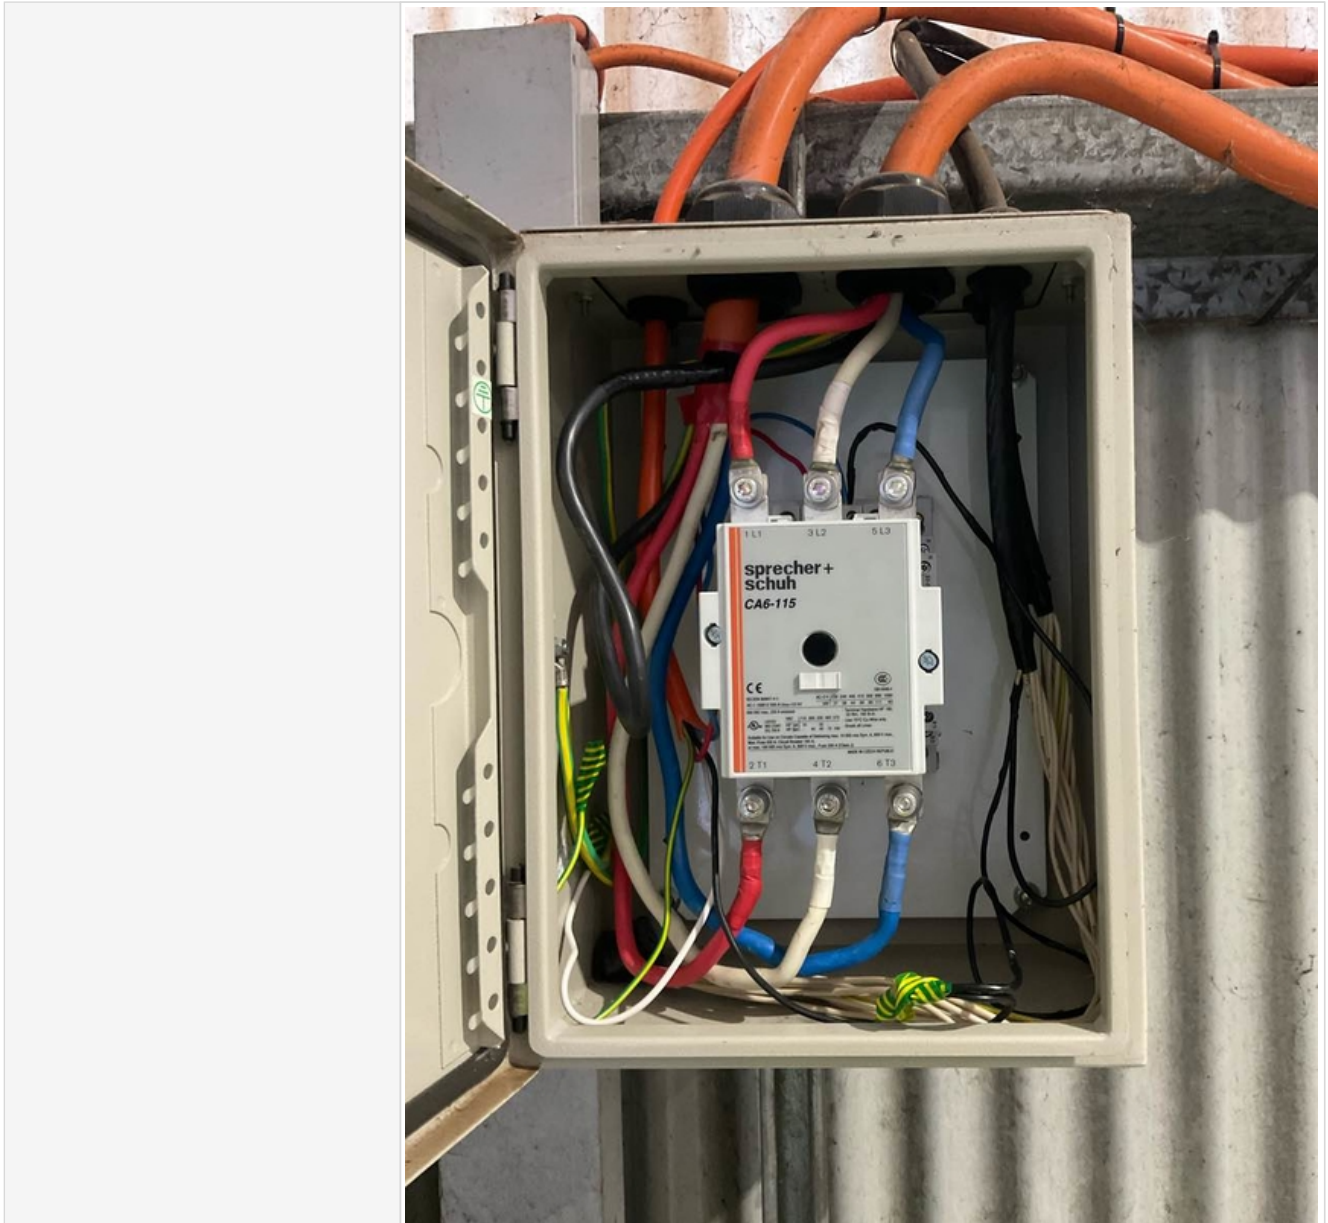
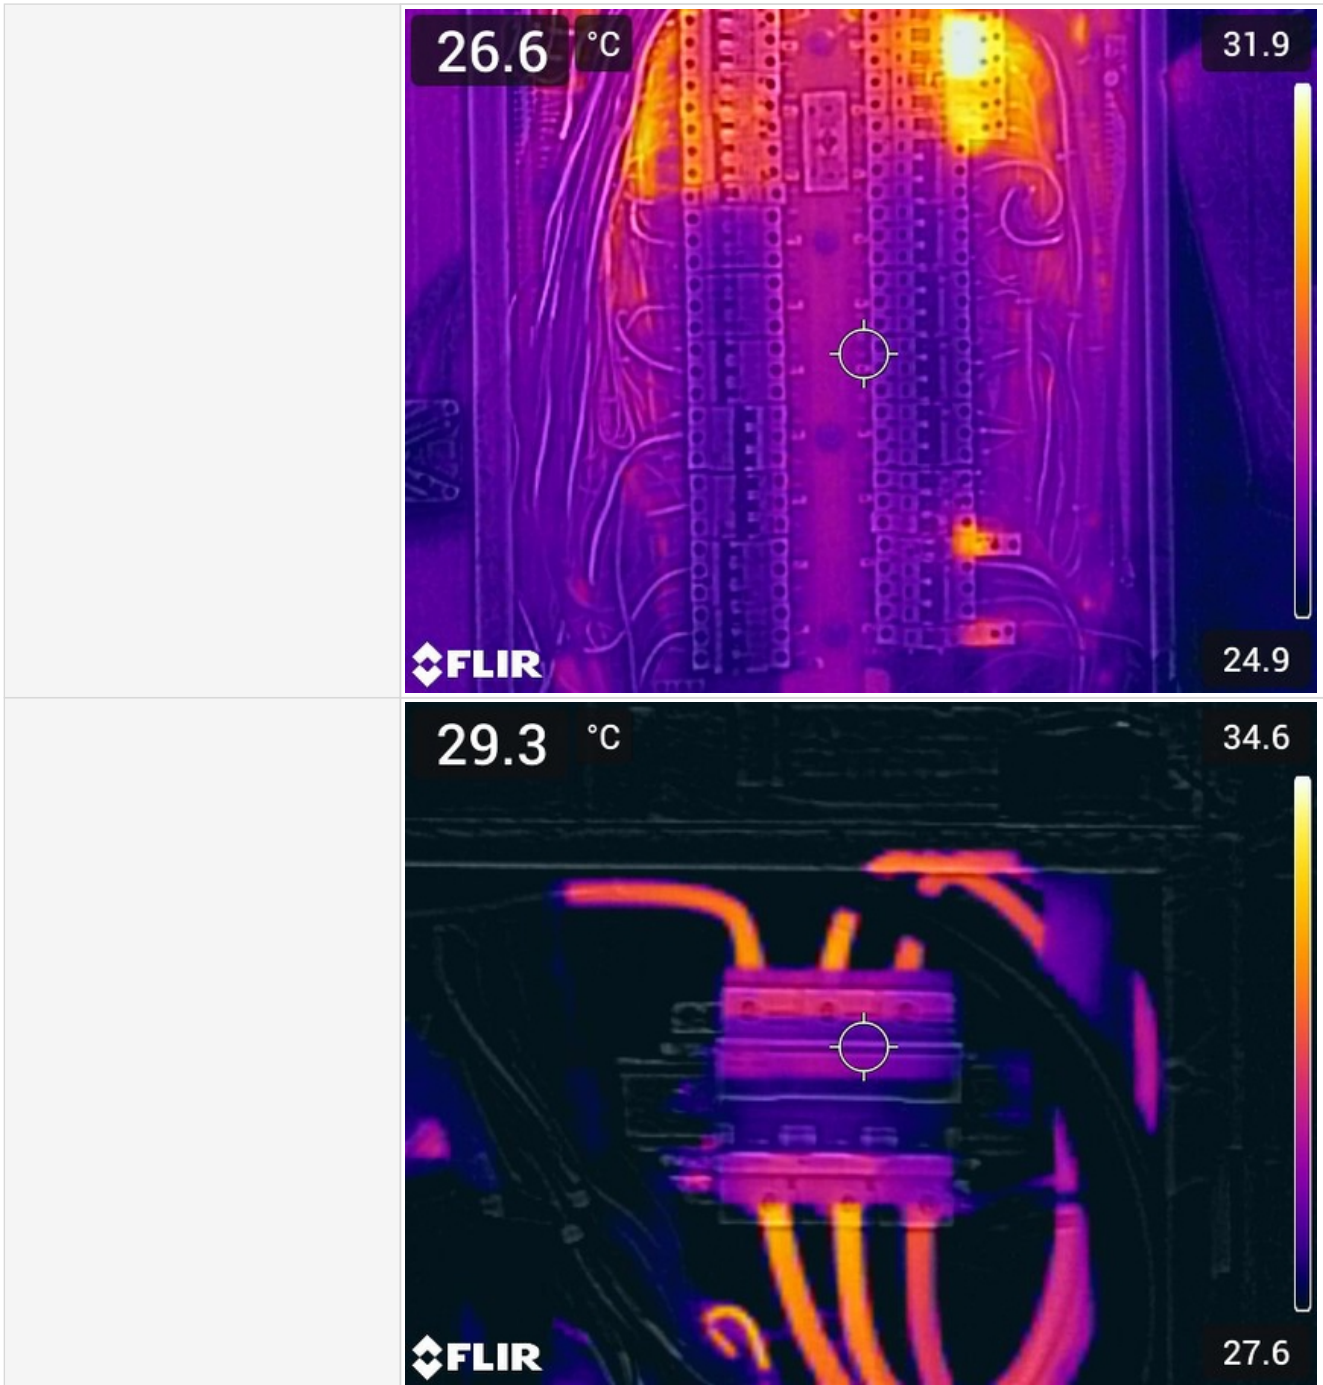
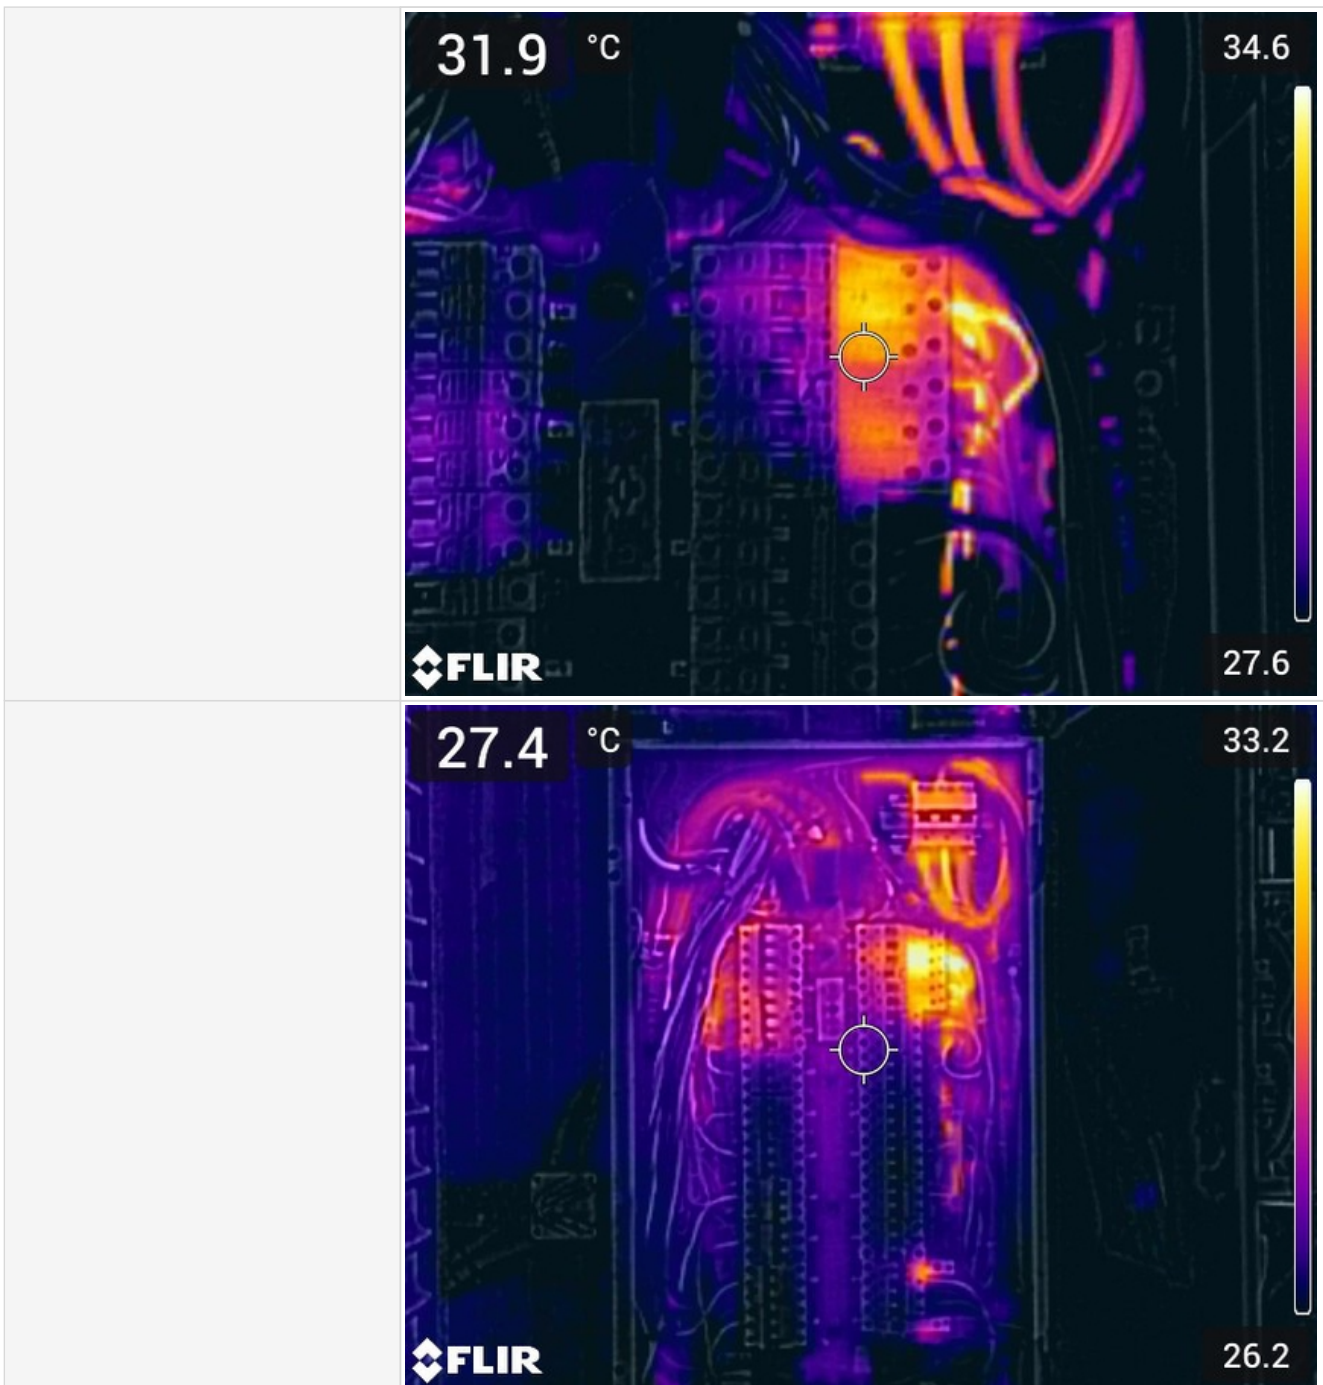
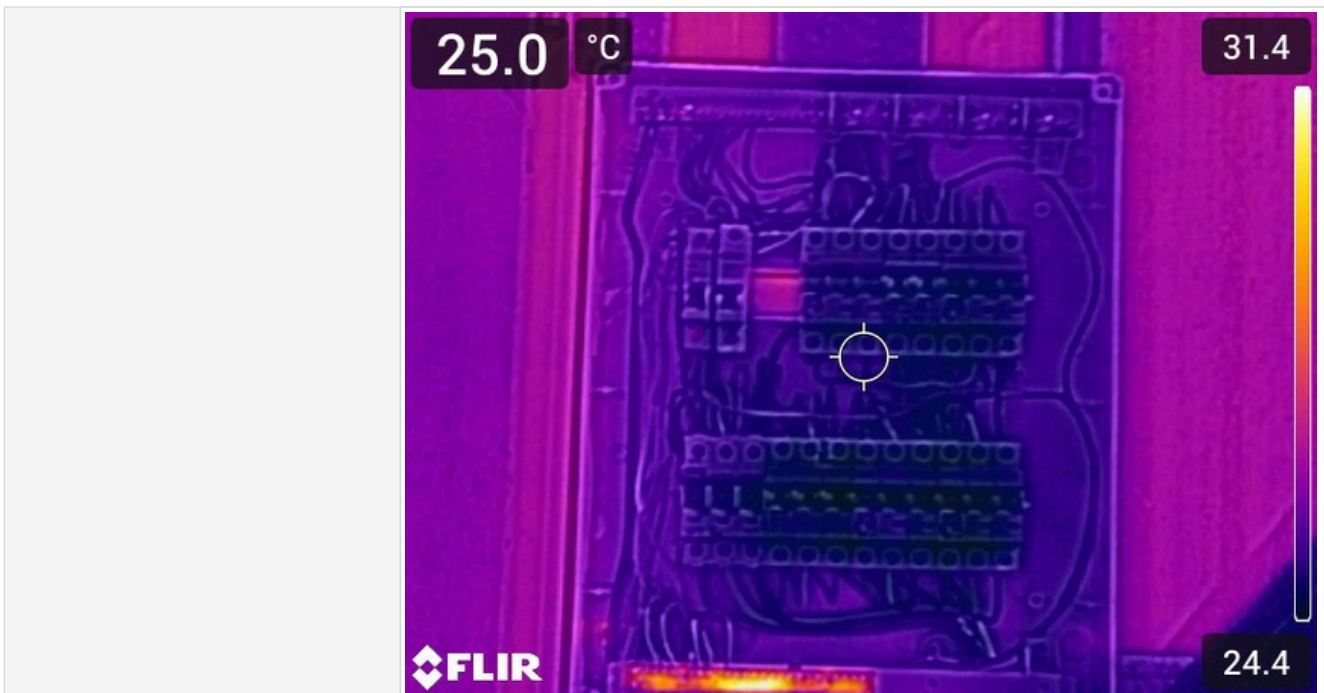
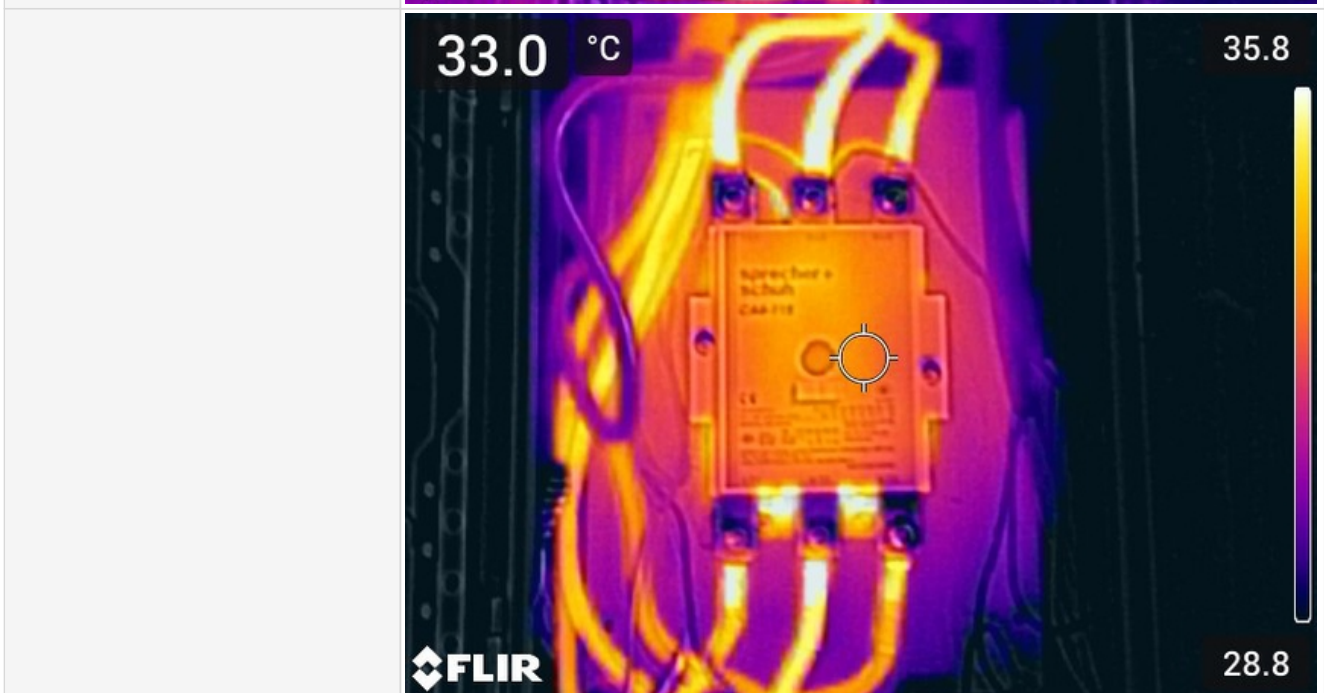
DB Location	Winery
DB Name	Sub 1
Number of RCD per board	8
SWB neatly Labelled or is there a DB Legend?	Yes
Is the Insulated Busbar in good condition?	Yes
Are there any Missing Pole Fillers?	No
Missing Screws?	No
Wiring Condition?	Fair
Are there any Holes / Penetrations on the board?	No
Are electrical circuits RCD protected?	Yes
Are there Recalled RCD's Installed?	No
Thermal Status	Pass

Switchboard Inspection Status	Pass
Comments and Recommendations	All in good condition
Next inspection Due	Feb 2026
